**Rebow House,
Colchester,
Essex**

Heritage Asset Assessment

**Rebow House,
58-62 Head Street,
Colchester, Essex**

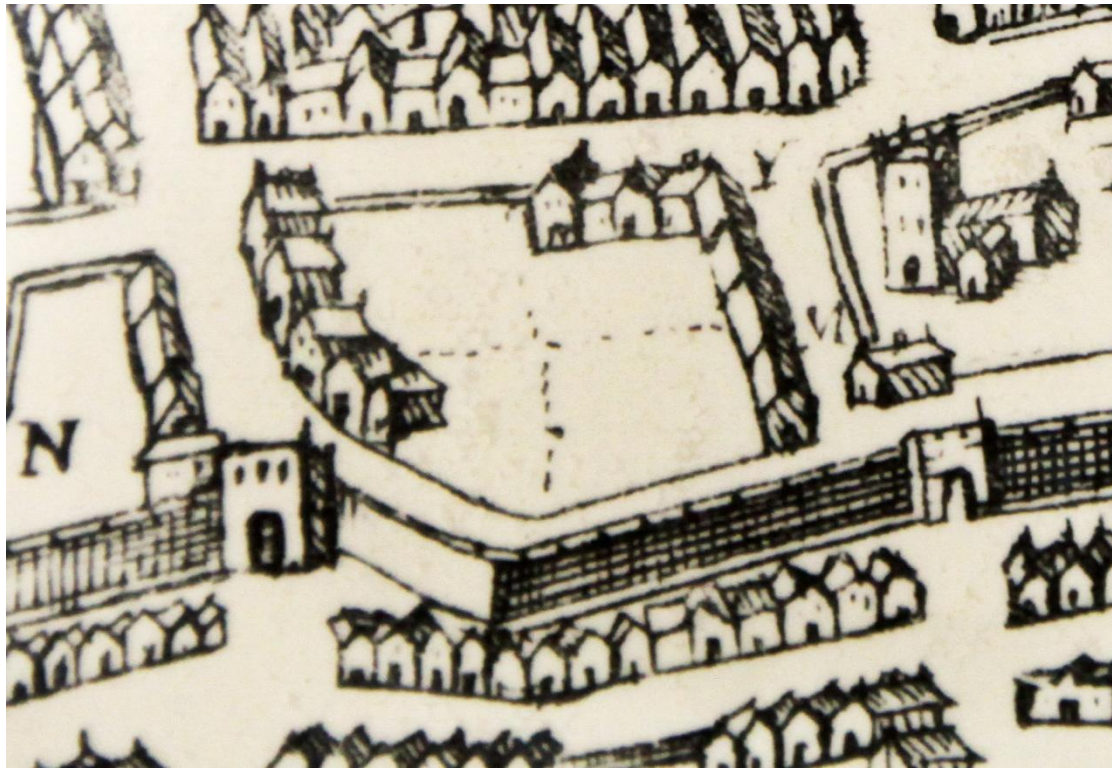
Figure 2a. A detail of the 1610 map. The gabled buildings to the right of Head Gate presumably occupy the site of the medieval cellar, with an empty plot of land to the north of what is now Sir Isaac's Walk.

Speed's highly stylised but generally accurate map of 1610 (figure 2) shows the intact gate with a row of medieval or Tudor gabled structures on the approximate site of the building, with an empty plot of land to the rear (east). There is nothing to indicate a property of unusual scale or importance. Deane's map of 1745, in contrast, shows the same empty plot, now laid out as a pleasure garden with geometrical paths, and a substantial mansion house on the corner of Head Street and 'Sir Isaac Rebow's Walk'. The building is one of only four houses in the entire town to be illustrated in perspective, with its facade turned towards the viewer to emphasise its quality and status.

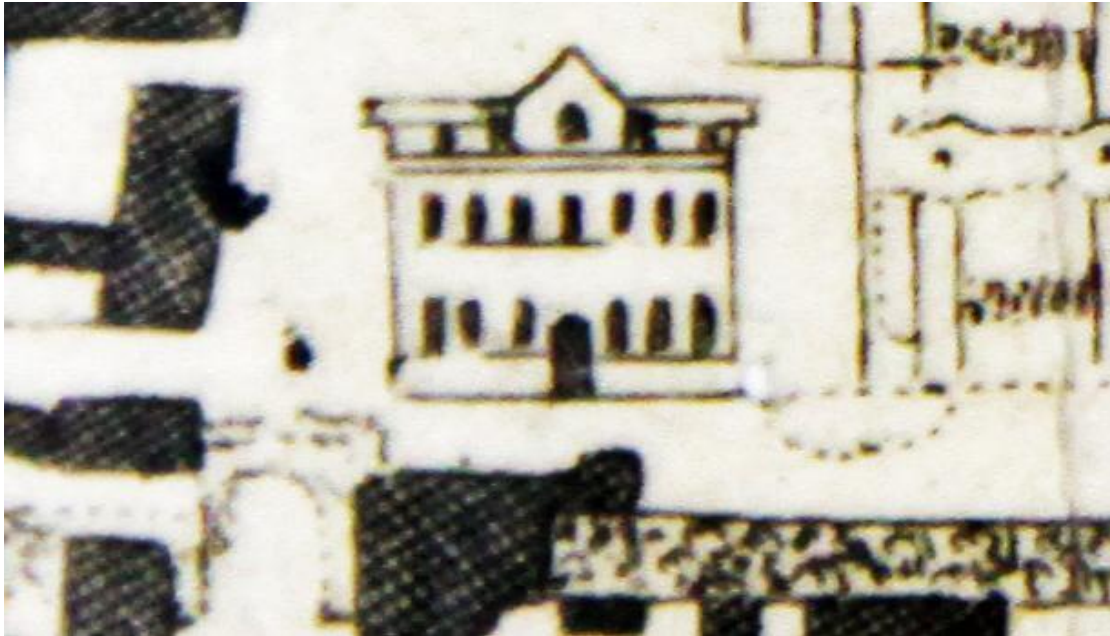
Figure 3a. A detail of the house on the 1745 map, one of only four domestic properties in the town of sufficient importance to be shown in profile. The low attic storey with its large central gable or dormer window is highly unusual, explaining the present recessed roof, and appears to lie above a parapet or cornice. Three windows flank the central axis instead of the two replacements of today. Note the gate on the left, which was demolished in the 1750s, and the town wall shown in plan-section to the south.

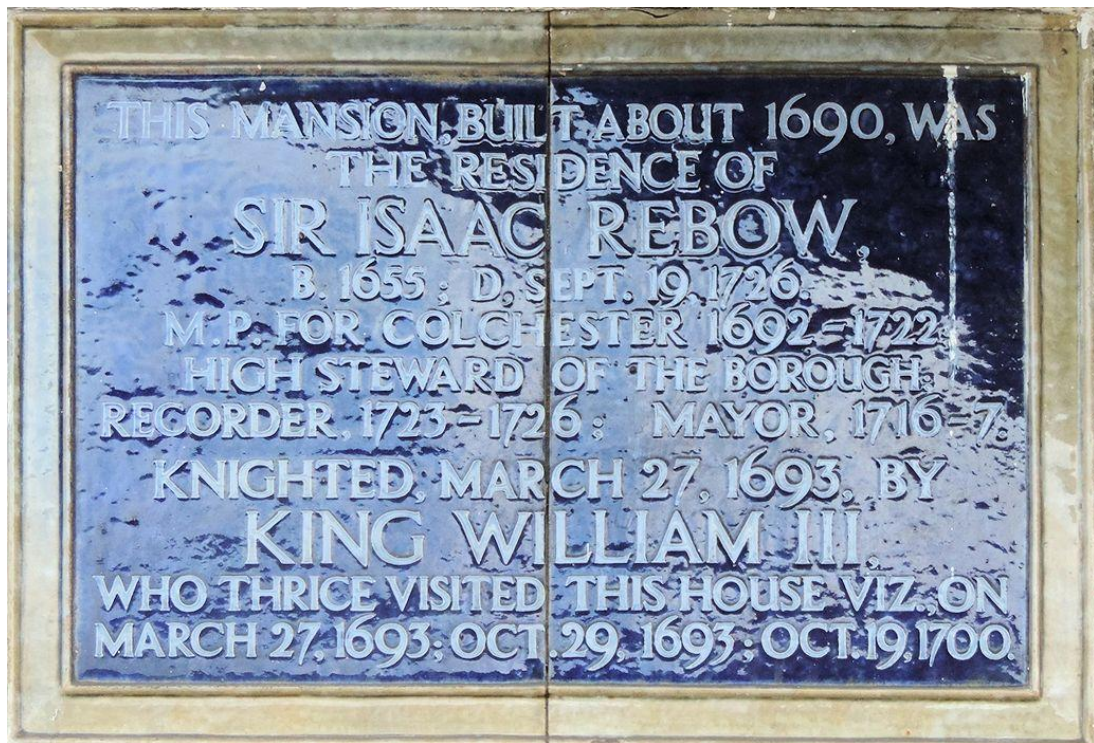
Figure 12

A detail of the fine late-19th or early-20th century terracotta ‘blue plaque’ on the front of the house which is an historic feature in its own right (shown to the left in illus. 2). Isaac Rebow was on familiar terms with William III, perhaps because of their shared Dutch ancestry, and Morant confirms all three of the king’s visits cited here. He may have dined in the principal reception room on the upper storey, which was remodelled in the early-19th century, or in the large front room of the charity shop.

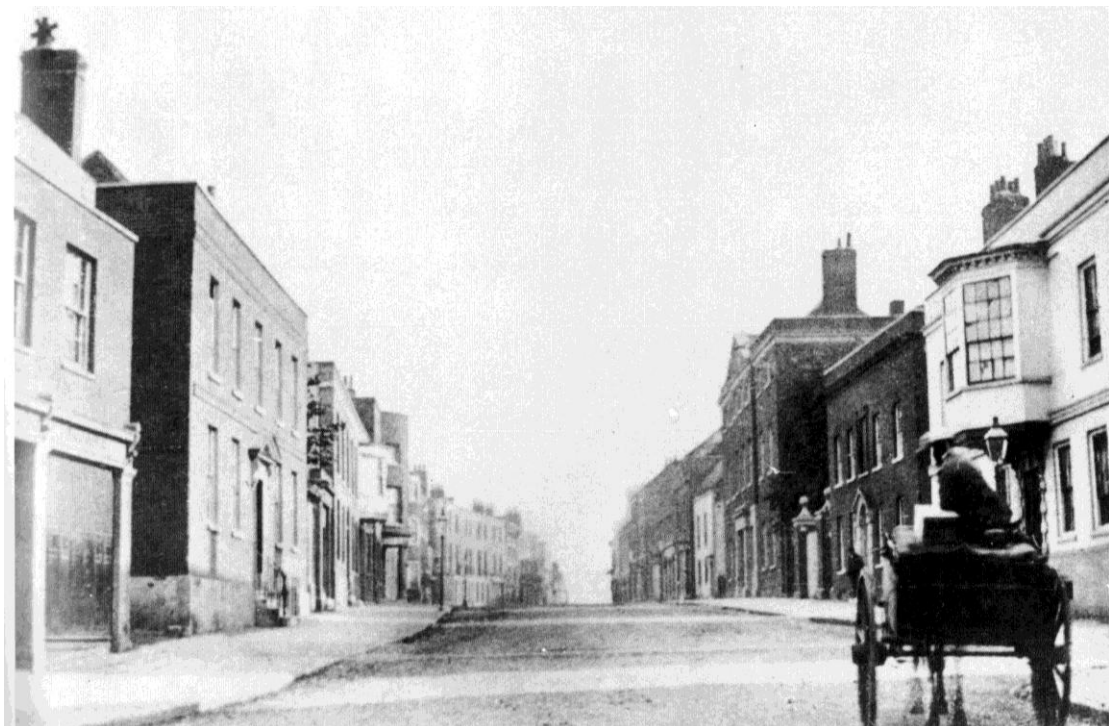
Figure 13. An early photograph of Head Street dated *circa* 1865 and published in the VCH History of Colchester. The original is in Colchester Museum.

central window with the principal entrance beneath. This entrance door had a ‘rusticated’ surround of projecting chamfered blocks of stone - or plaster imitating stone – again in the fashion of *circa* 1700. The present shop facades were not added until the end of the 19th century as illustrated by figures 13-17, and the rusticated door survived into the mid-20th century.

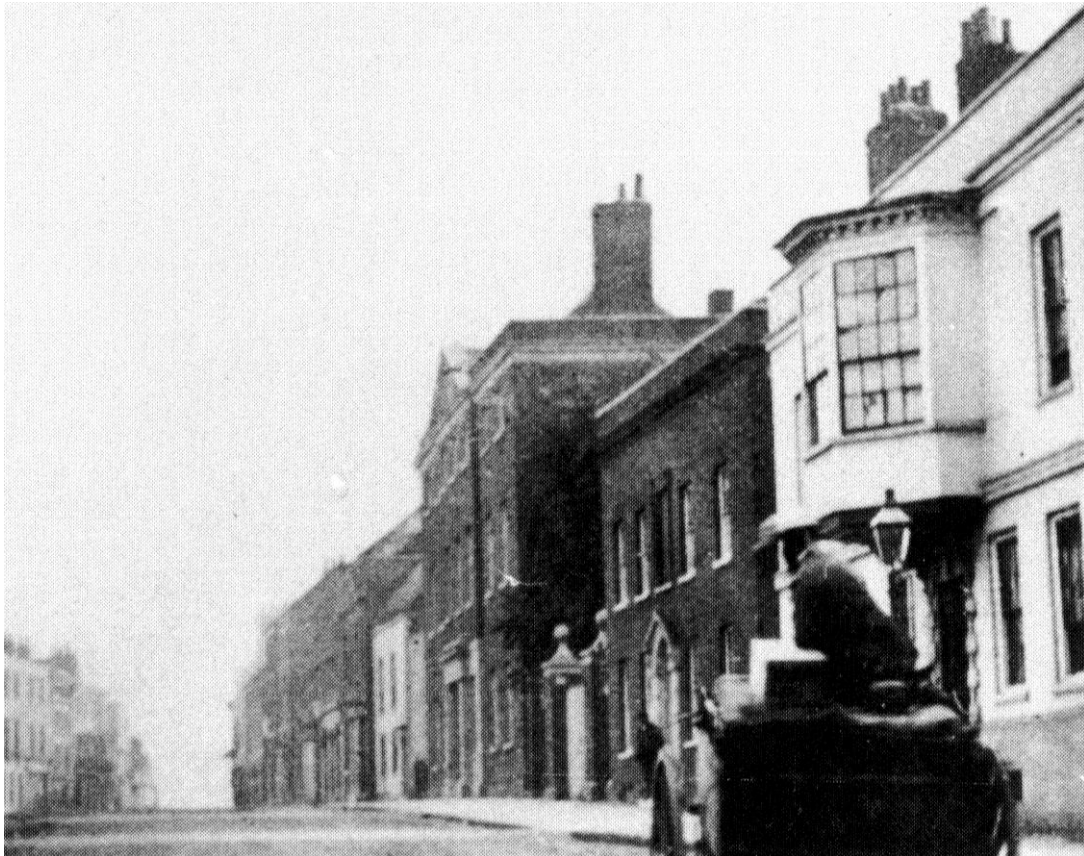
Figure 13a. A detail of the *circa* 1865 photograph. The house is annoyingly obscured by traffic – then as now - but a rusticated door surround is visible beneath the oriel window with two sash windows to its right and what appear to be two others to its left. There is no indication of shop facades. The rustication of the door surround is typical of the late-17th and early-18th centuries and was probably reflected in the original windows. Note the moulded string course of which only a fragment now survives on the southern wall.

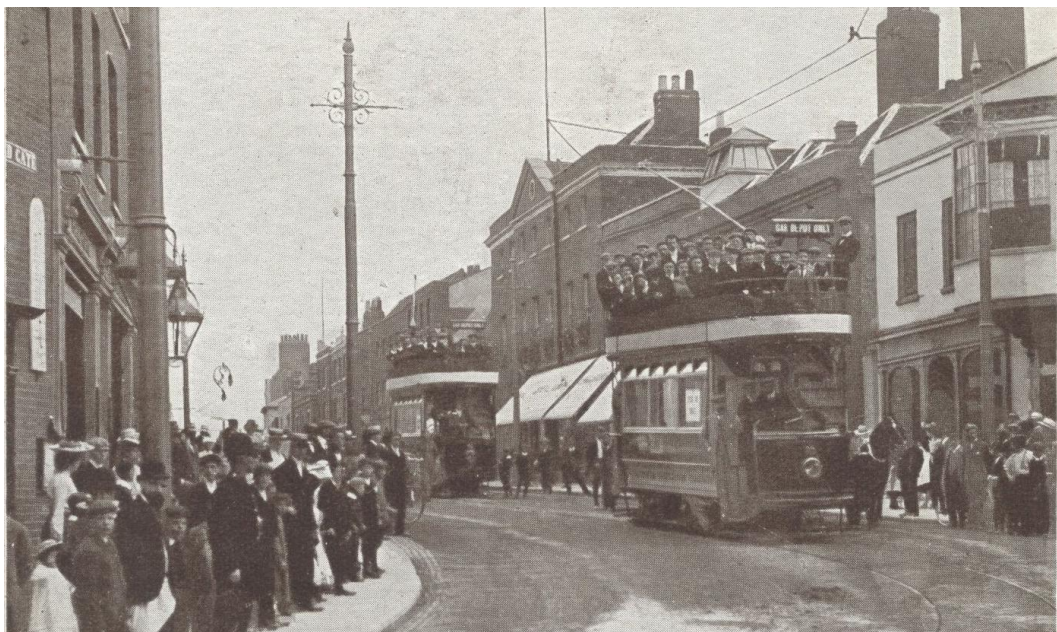
Figure 14. A printed photographic postcard entitled ‘opening of Colchester Electric Tramway 28th July 1904’. A shop front had been added to the left of the oriel window since 1865.

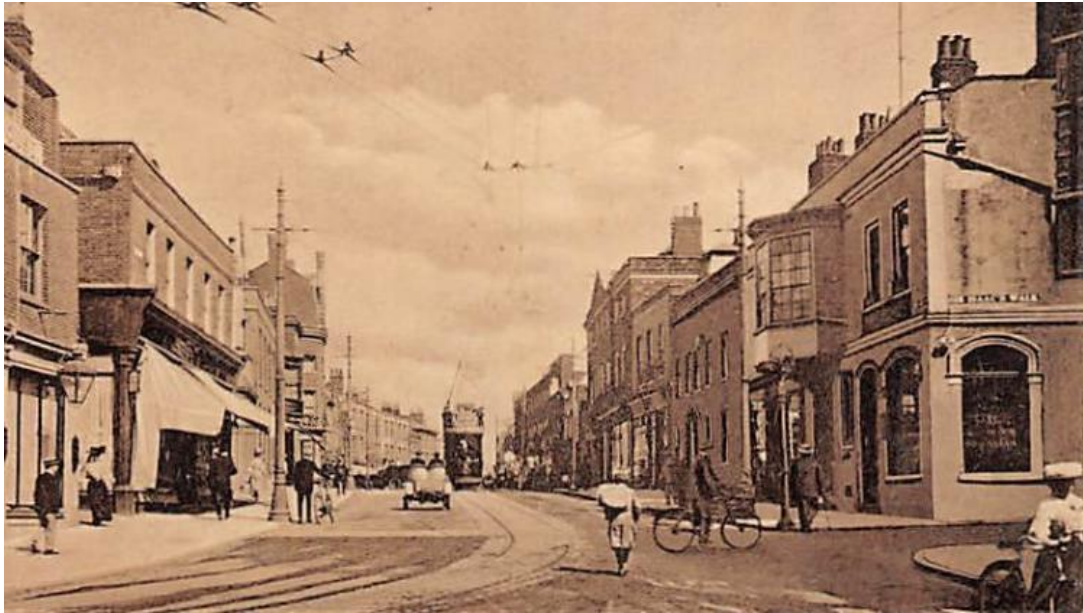
Figure 15. A photographic postcard of the same view posted in May 1911, with the arched windows and entrance of the southern shop much as they remain today. This shop front was added after *circa* 1865 as its doorway replaced the right-hand sash window shown in figure 13.

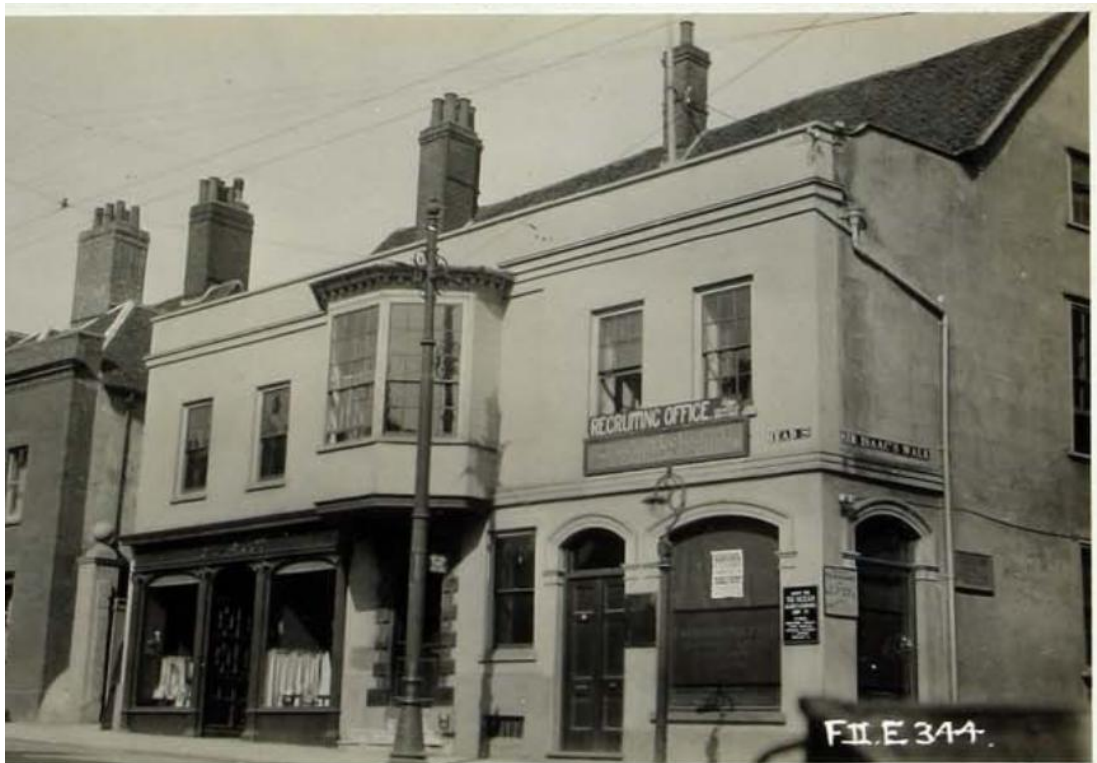
Figure 16. The house photographed in 1921. The original rusticated door surround still survived beneath the central oriel, and note the presence of at least five pots on the left-hand chimney which has since been removed entirely (presumably serving back-to-back fireplaces on both the ground and first floors with another in the attic). The central chimney in contrast contains a single flue to heat the first-floor reception room. The presence of a first-floor recruiting office on the right may relate to the Votes For Women graffiti in the attic (illus. 32). The original glazing of the lower sashes of the first-floor windows was still intact at this date. (Royal Commission archive.)

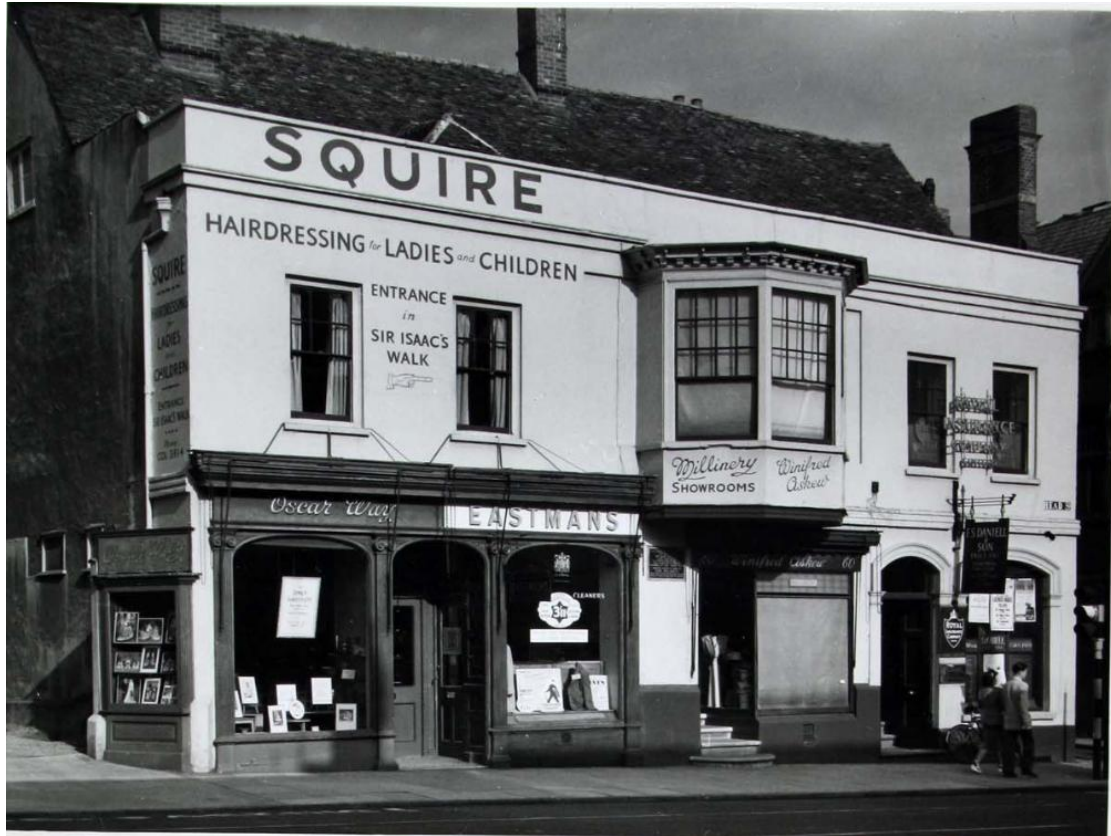
Figure 17

The house in 1951. The first-floor rooms to the left remained in use as a hairdressing salon until recently, which explains their exotic decor. A third shop front had been added to the centre of the building since 1921, destroying the original rusticated door surround, but the two chimneys remained intact. The original glazing bars of the lower first-floor sashes had been replaced with plate glass. Note the small shop window to the extreme left which appears to project at an angle into the vehicle access; this has since been replaced by a copy of the two main windows.

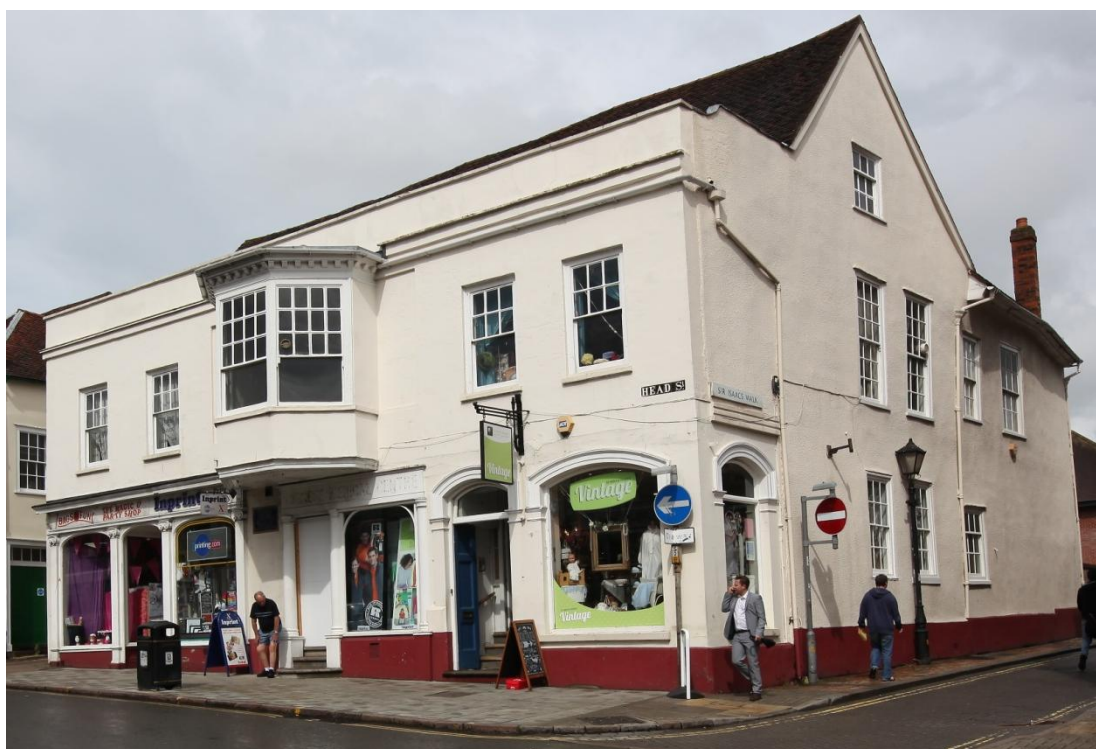
Illus. 1

The Head Street facade, with Sir Isaac's Walk on the right. The parapet is divided from the tiled roof by a wide section of flat leadwork which reflects the unusual attic storey depicted in 1745 (figure 3). The present first-floor windows to Head Street were renewed in the early-19th century but the recesses of two of the original seven windows are still visible on each side of the central oriel. These windows were much taller than their replacements, and would have created a highly imposing display. The two first-floor windows of the southern gable to the right preserve their original proportions, although their sashes have been renewed. The shop fronts to the left and right of the building date from the end of the 19th century, and were not present in 1865 (figure 13), but the central shop beneath the oriel was added between 1921 and 1951 (figures 16 & 17). The internal floor level is indicated by the red paintwork which coincides with the ceiling in the medieval cellar: the number of entrance steps necessary to reach this level diminishes from right to left as the ground slopes upwards. The chimneys shown in 1951 have been removed. Note the fragment of moulded string course above the southern shop window; this formerly extended along the entire Head Street facade and could be restored as far as the oriel window to enhance the building's appearance.

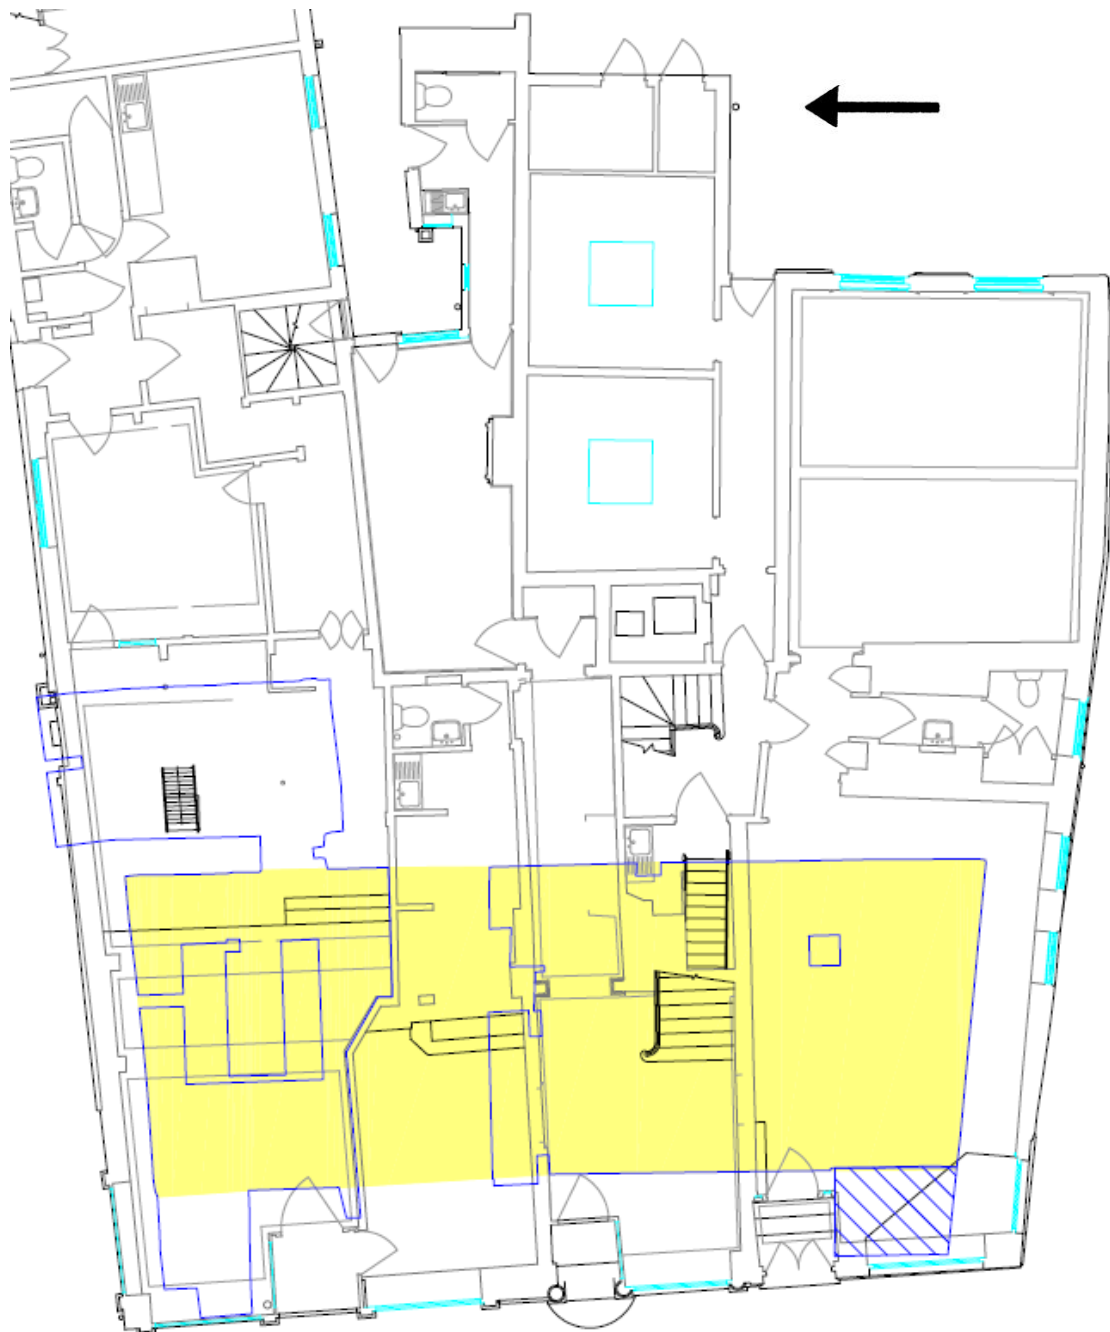
Figure 21. Ground plan by Randalls indicating position of medieval cellar in yellow.

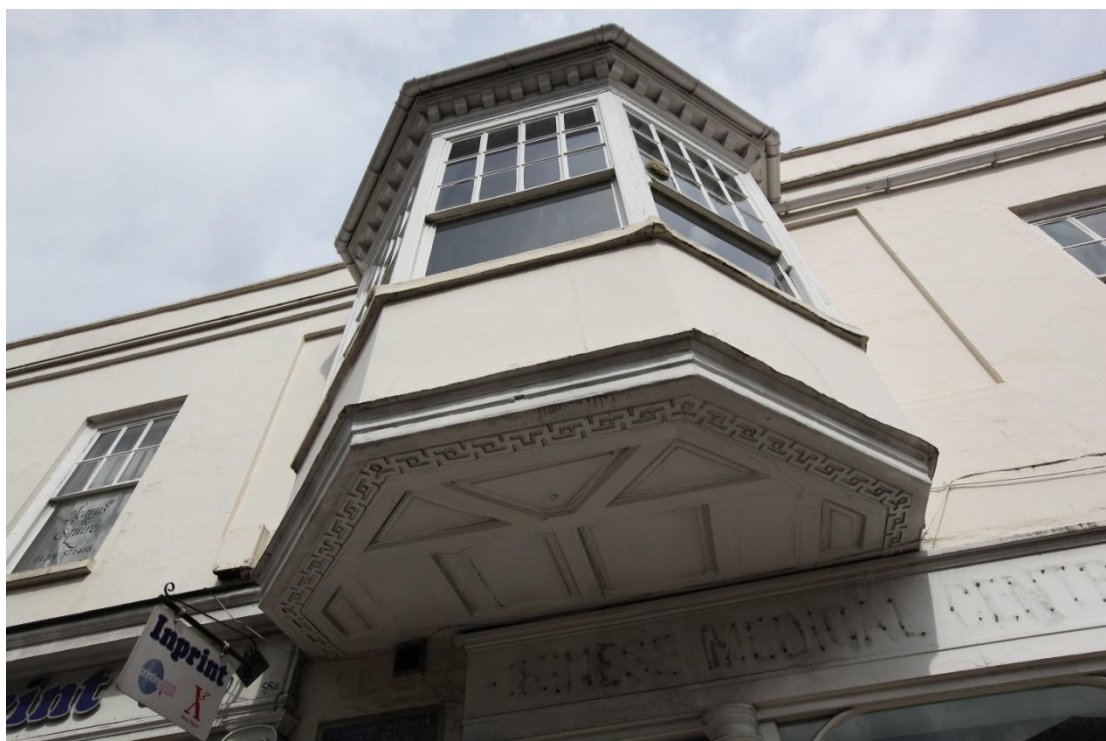
Illus. 2

A detail of the fine Regency-style oriel window showing the Greek Key border of its panelled soffit and the tall recesses of the blocked original first-floor windows to left and right. This version of the Greek Key incorporates a swastika, and was a popular motif in the early-19th century long before the motif acquired more sinister overtones. The original entrance door beneath this oriel boasted a rusticated surround in typical William & Mary/Queen Anne style (figures 13 & 16), but this was destroyed by the present shop front. The lower glazing bars of the early-19th century sashes were sadly replaced by sheet glass between 1921 and 1951 (figures 16 & 17).

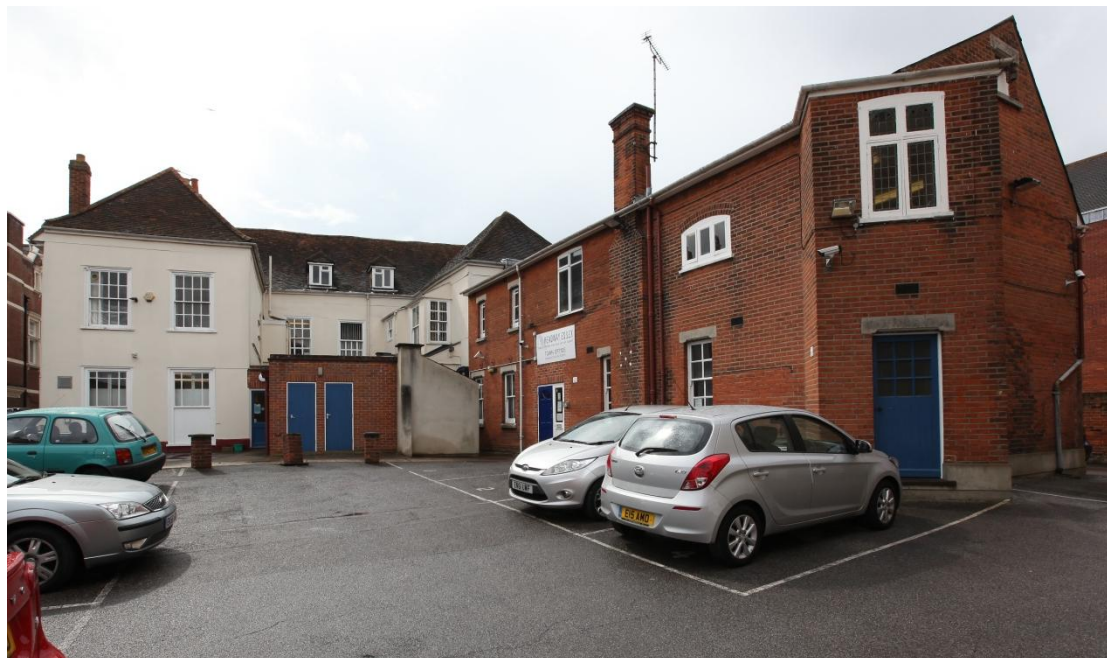
Illus. 3

The rear yard, showing the two cross-wings with hipped gables divided by a variety of late-19th and 20th century flat-roofed extensions. The red-brick range on the right was built as office accommodation between 1897 and 1909 (figures 6 & 7). The most recent

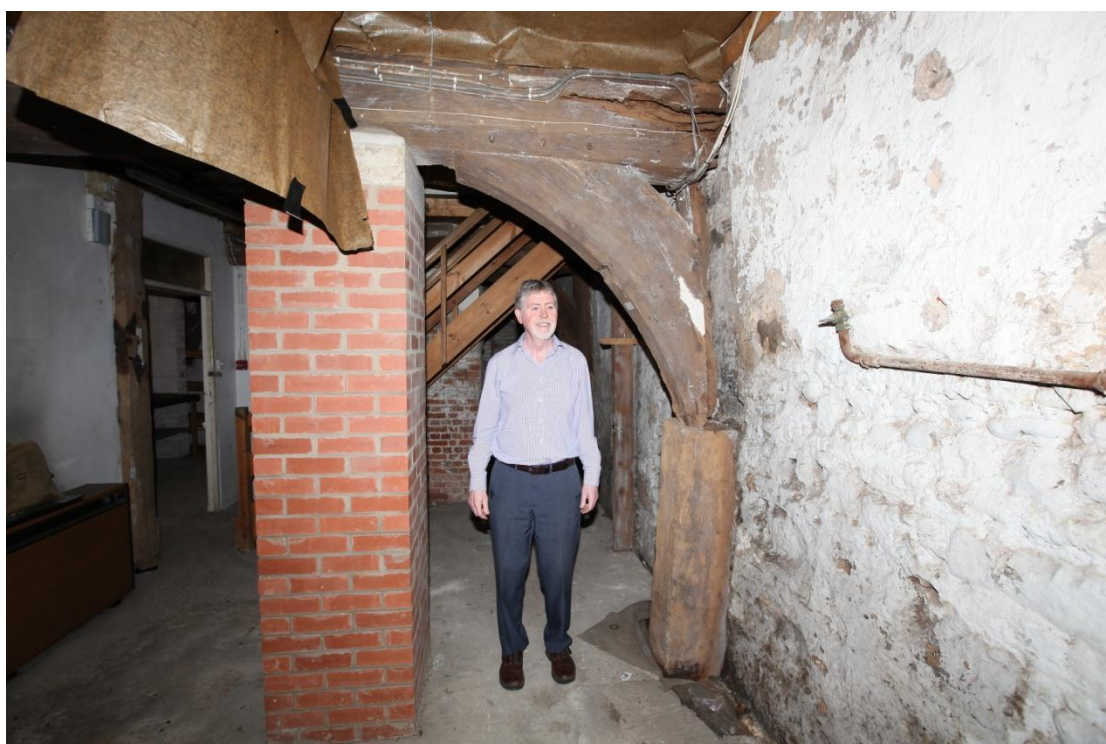
Illus. 4

The medieval cellar showing the exceptional scale of its ceiling timbers, with a 9 inch thick brace supporting a joist of 16 inches by 15 which extends to over 18.5 ft in length. The underside of this joist is 7.5 ft above the modern concrete floor, and the fabric of the rear (eastern) wall on the right consists of flint-rubble with no evidence of the brickwork that might be expected after the 14th century. The block of red brick in the background supports the early-19th century chimney which now heats the reception room behind the oriel window (S), and may have been designed for a larger chimney in the original house of *circa* 1700.

Later alterations to the cellar also include the insertion of an arched block of 17th century brickwork which was clearly designed to serve as a foundation for the chimney adjoining the main staircase immediately above. The relieving arch in this brickwork has been provided with a panelled door to serve a small strong-room. A similar block of brickwork lies in the northern cellar beneath the missing chimney that formerly divided areas B & C. In more recent years a concrete floor has been inserted together with the partitions of a storage cupboard in the southern cellar's north-western corner, and a brick supporting pier has been built under the southernmost binding joist as shown to the left in illus. 4.

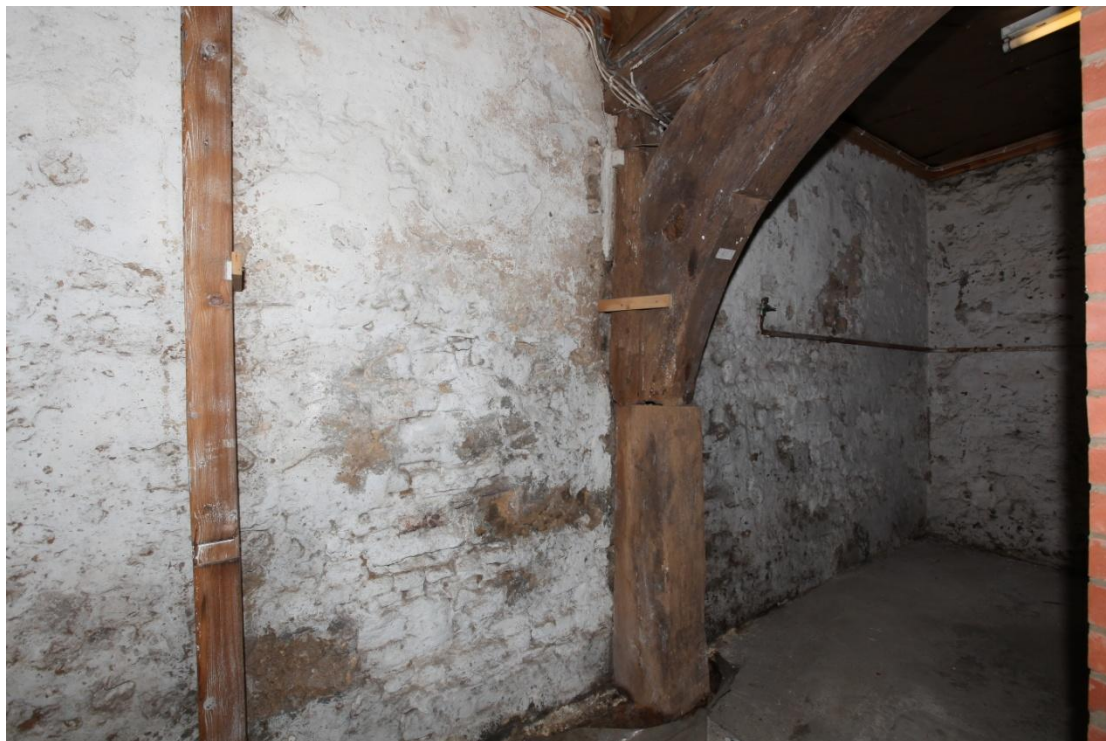
Illus. 5

A view from the north of the brace in illus. 4 showing the original wall piece to which it is tenoned and pegged, with concave chamfers to all three timbers. The wall piece now rests on a later post and it is unclear whether the rear wall was provided with stone corbel blocks to match the front. The flint rubble wall of the southern gable is visible in the rear.

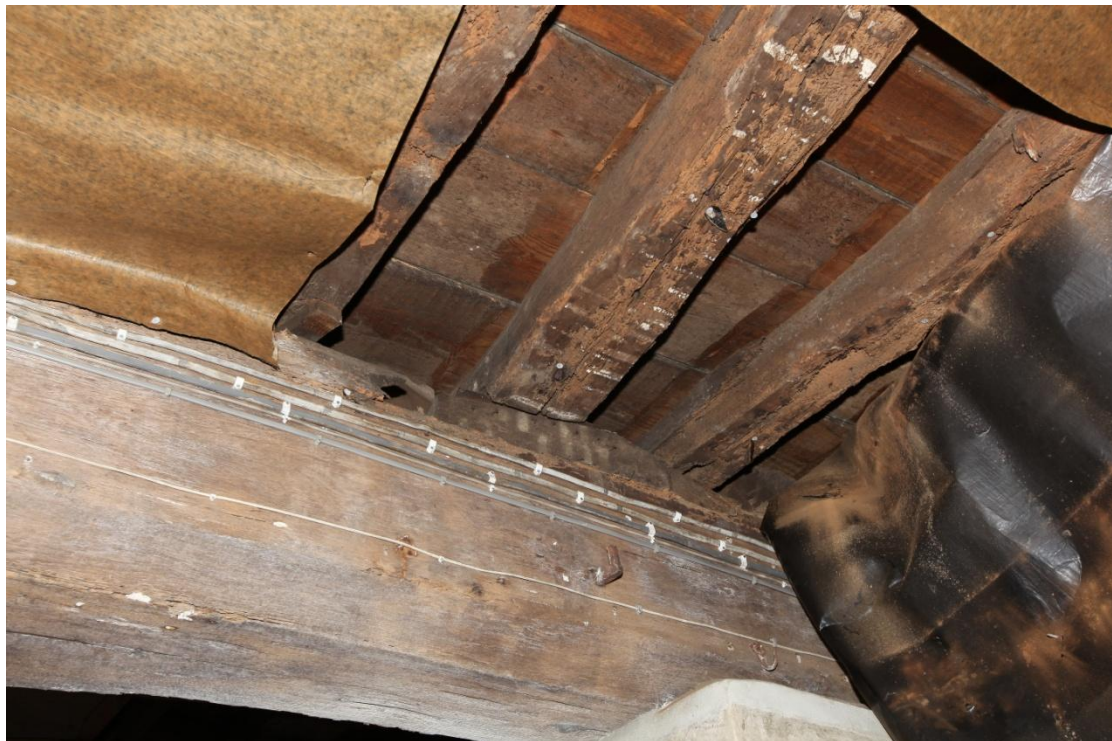
Illus. 6

A detail of the principal joist in illus. 4 showing the common joists lodged on top rather than tenoned to its sides. Lodged joists of this kind are normally found in the 13th century and before, but may have been used here at a slightly later date to maximise strength. There is nothing to guarantee that any individual common joist has not been replaced.

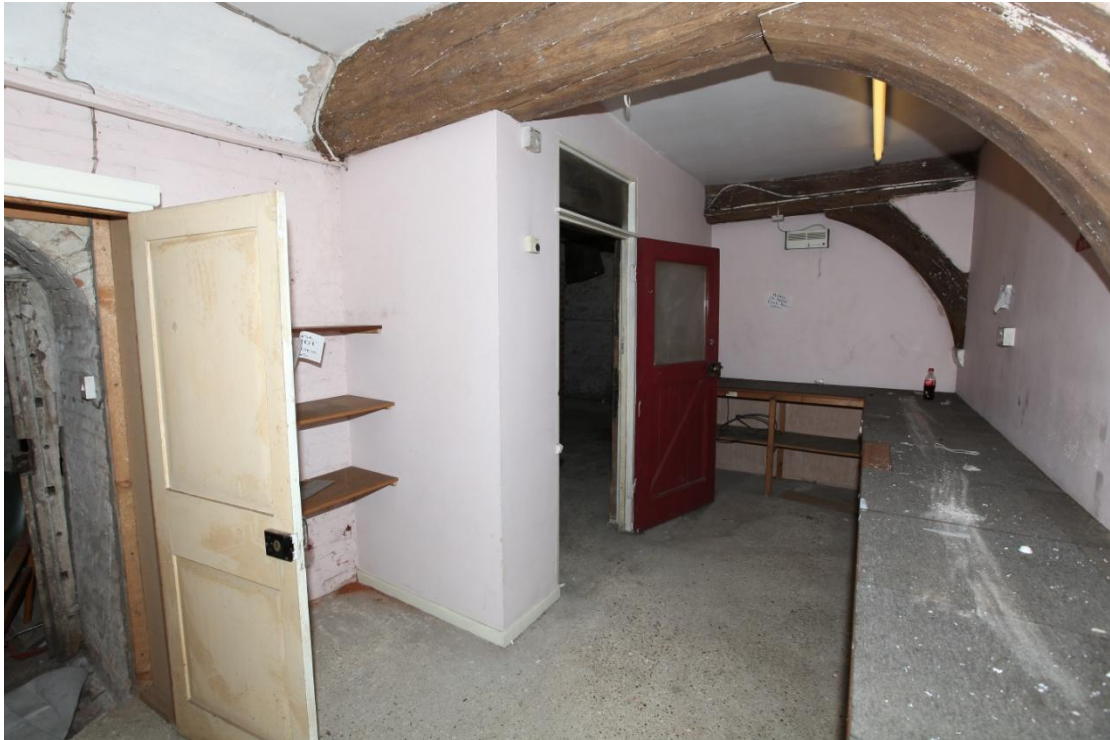
Illus. 7

The cellar beneath the central entrance, with a 20th century partition adjoining the brick chimney foundation on the left. The latter is pierced by an arched storage recess with an ostensibly original boarded door of *circa* 1700. The front (western) wall on the right is concealed by 20th century dry-lining (i.e. plasterboard) through which medieval stone corbels project to support the ceiling braces. Identical corbels are visible in the northern section of the cellar beneath the party shop.

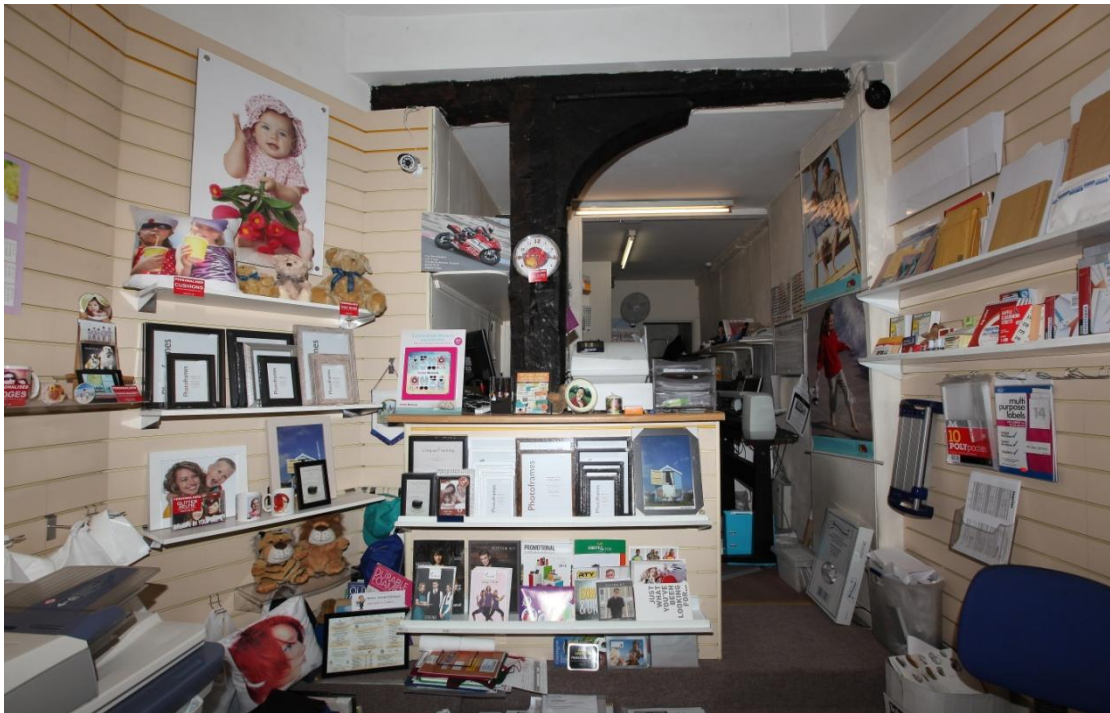
Illus. 8. The 15th century doorway in the print shop (D-E) with the partition adjoining the central entrance hall (F) on the right. A missing bracket formed a medieval arch, and mortises in the remaining left-hand jamb indicate the presence of a missing timber-framed wall that extended both to the front and rear. At 17 ft behind the Head Street facade this may represent a cross-passage, but it is impossible to determine whether more early framing is hidden in the later walls or even whether this fragment is *in situ*.

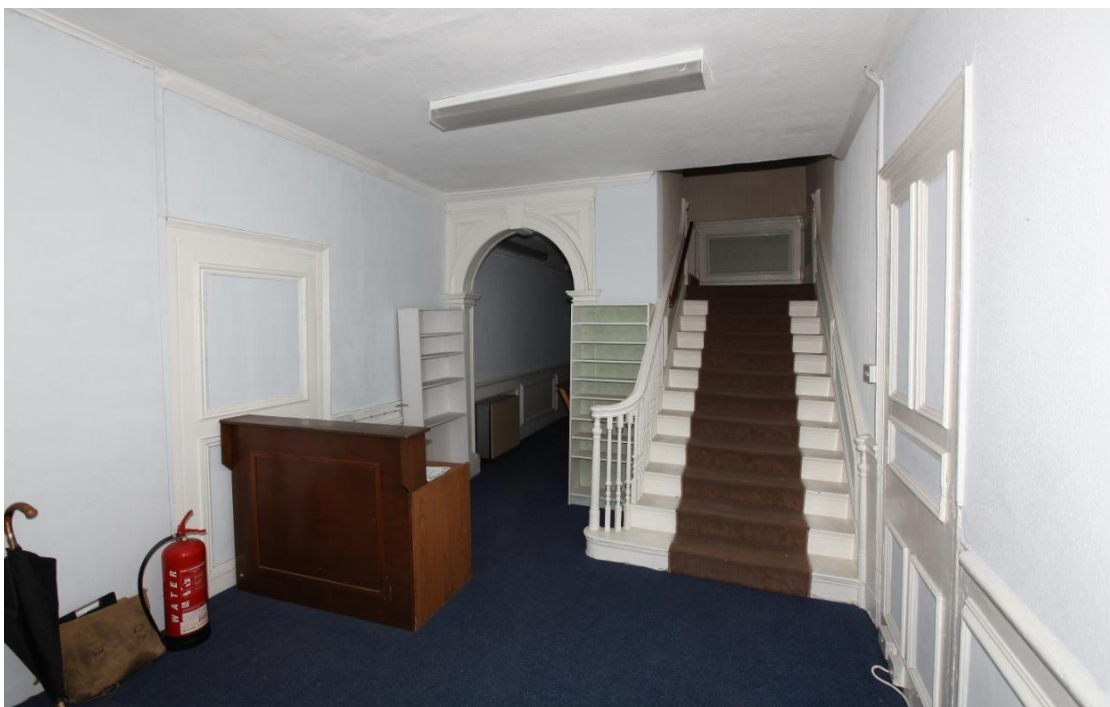
Illus. 9. The central entrance hall with its fine staircase and blocked doors opening into the print shop on the left and the charity shop on the right. The arch in the centre lies immediately beside the 15th century doorway in illus. 8 above, and may conceal another.

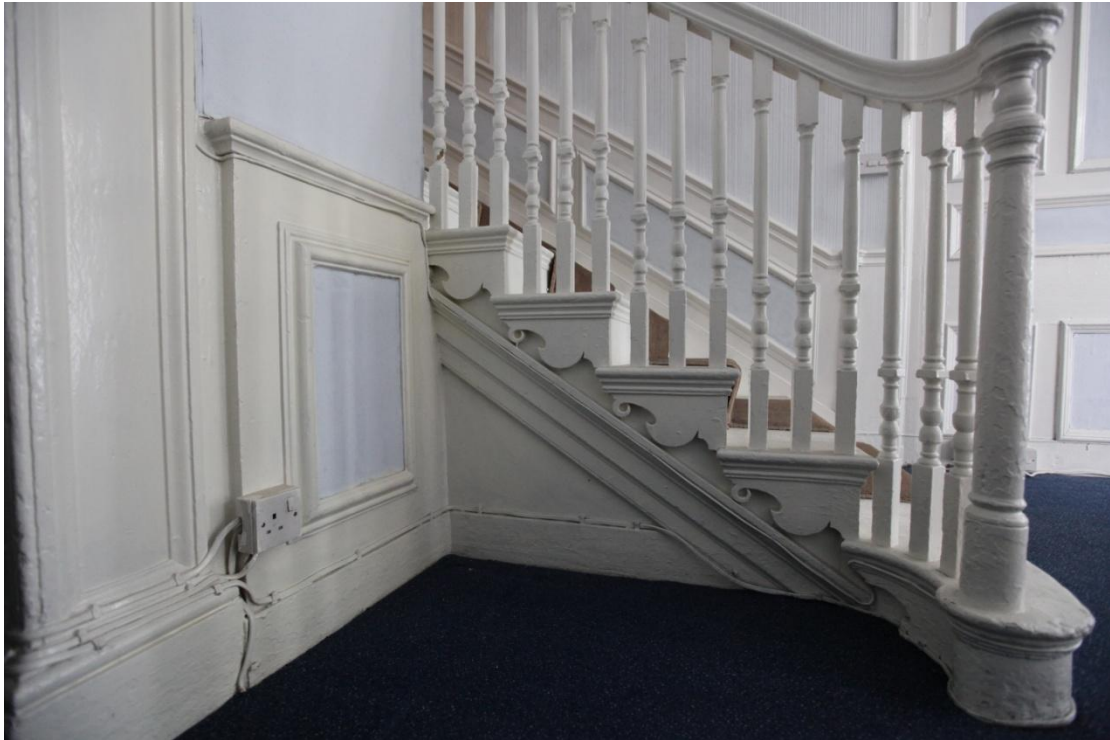
Illus. 10. A detail of the fine main staircase showing its moulded handrail and the decorative brackets of its open strings. This is highly unlikely to be as early as *circa* 1700 but is typical of the second quarter of the 18th century.

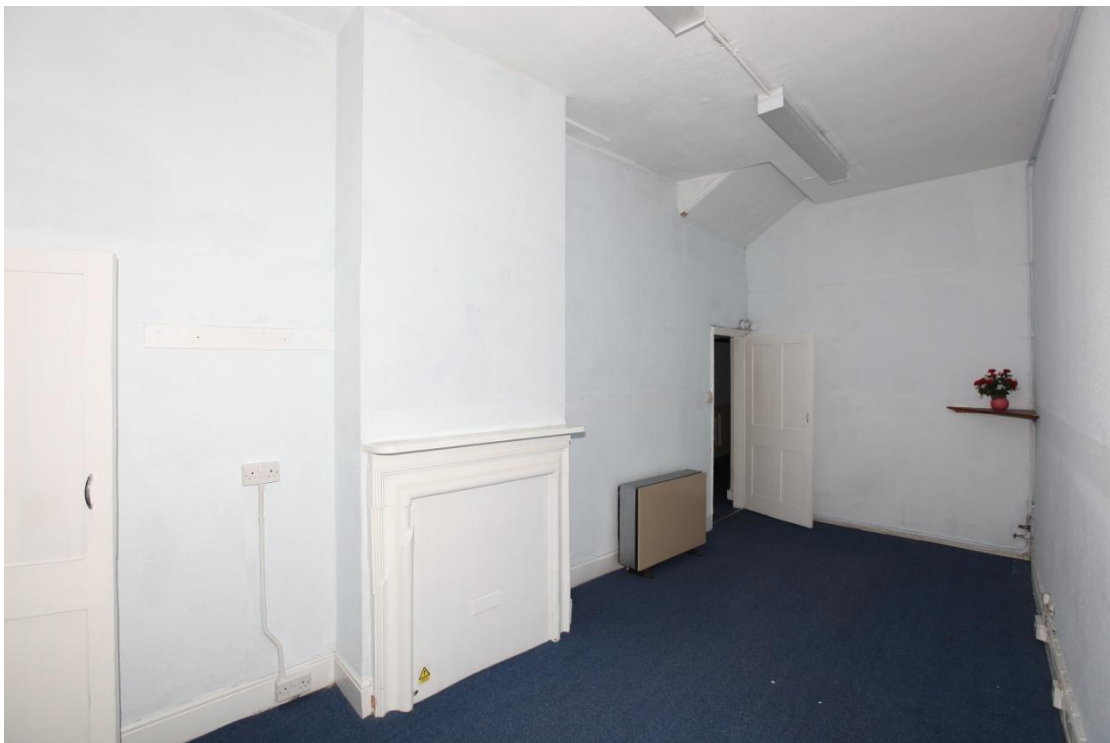
Illus. 11. The narrow room in the flat-roofed extension to the rear of the main stair passage (F), seen from the east. This room was added between 1897 and 1909 but the bolection-moulded stone fire surround on the left dates from *circa* 1700 and was probably moved from elsewhere in the house. The wall on the right consists of modern dry-lining and the Goad plans indicate doors opening into the adjoining photography shop (now the party shop).

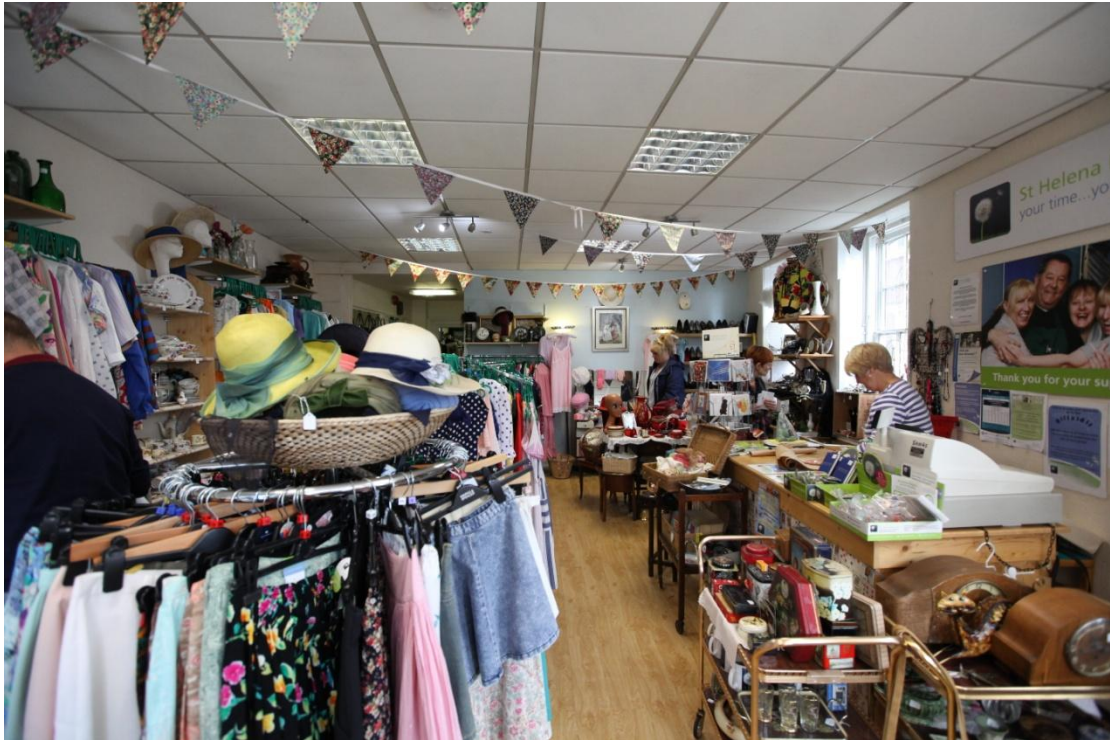
Illus. 12. The front ground-floor room of the charity shop (G) from its Head Street entrance, showing little evidence of historic fabric. A small section of wainscot is exposed in the far right-hand corner, adjoining Sir Isaac's Walk, and the false ceiling may conceal moulded cornices. The rear wall may contain a blocked fireplace.

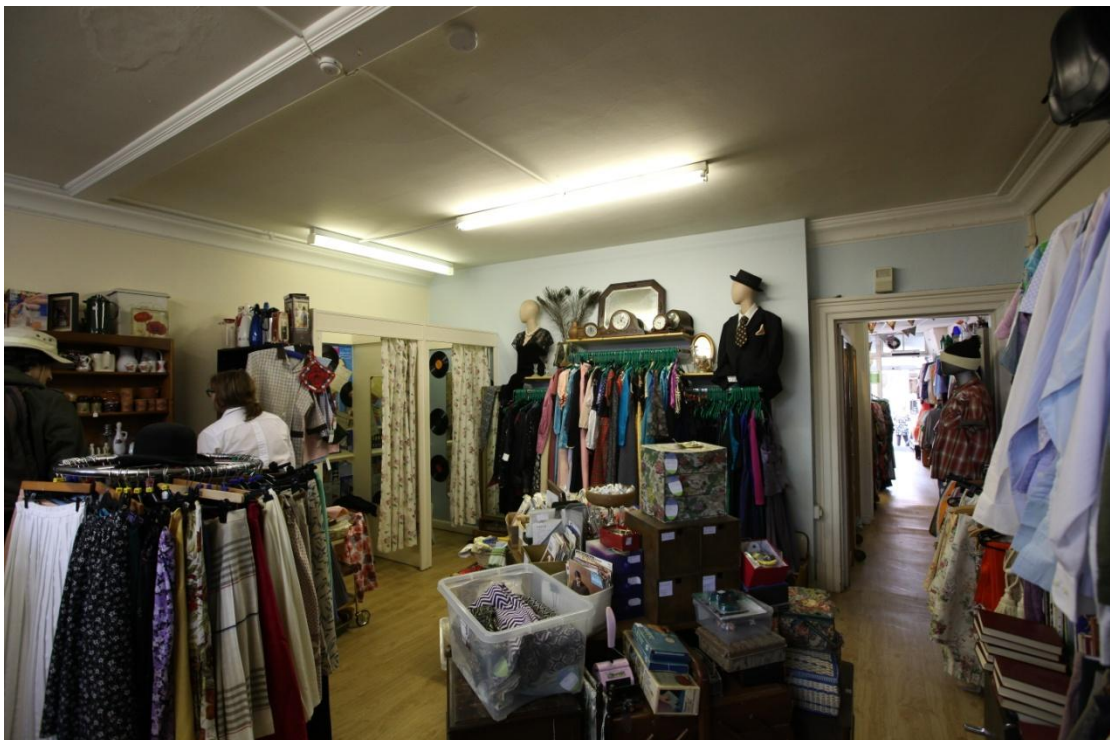
Illus. 13. The rear ground-floor room of the charity shop (H), seen from the east, with a good moulded cornice that probably survives from the original building. A tile hearth projects from the chimney in the centre but its fireplace is either hidden or removed and a WC now occupies the position of its chimney.
