**Rebow House,
Colchester,
Essex**

Heritage Asset Assessment

**Rebow House,
58-62 Head Street,
Colchester, Essex**

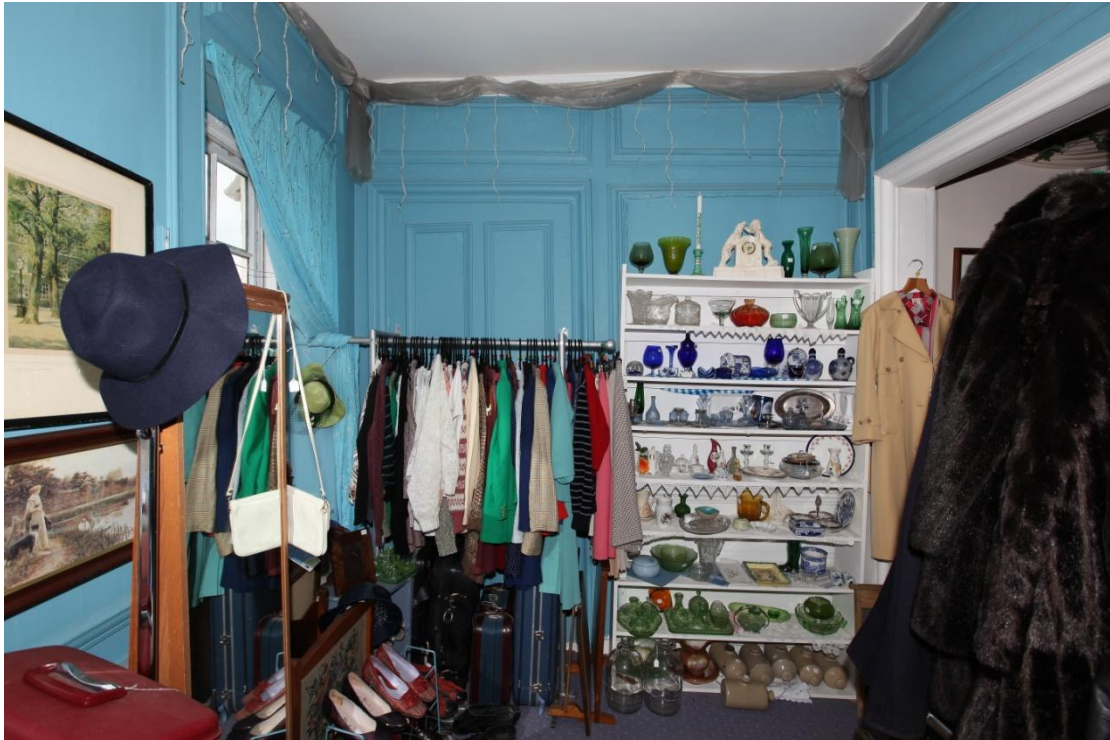
Illus. 14. The narrow first-floor room at the front of the charity shop (T), still lined with panelling of *circa* 1700, which probably served as a dressing room or lobby for the larger main bedroom to the right (U/V). The blocked original door in the centre opens into the main reception room with the oriel window (S). The panelling of the Head Street facade on the left was designed for taller sash windows than those of today.

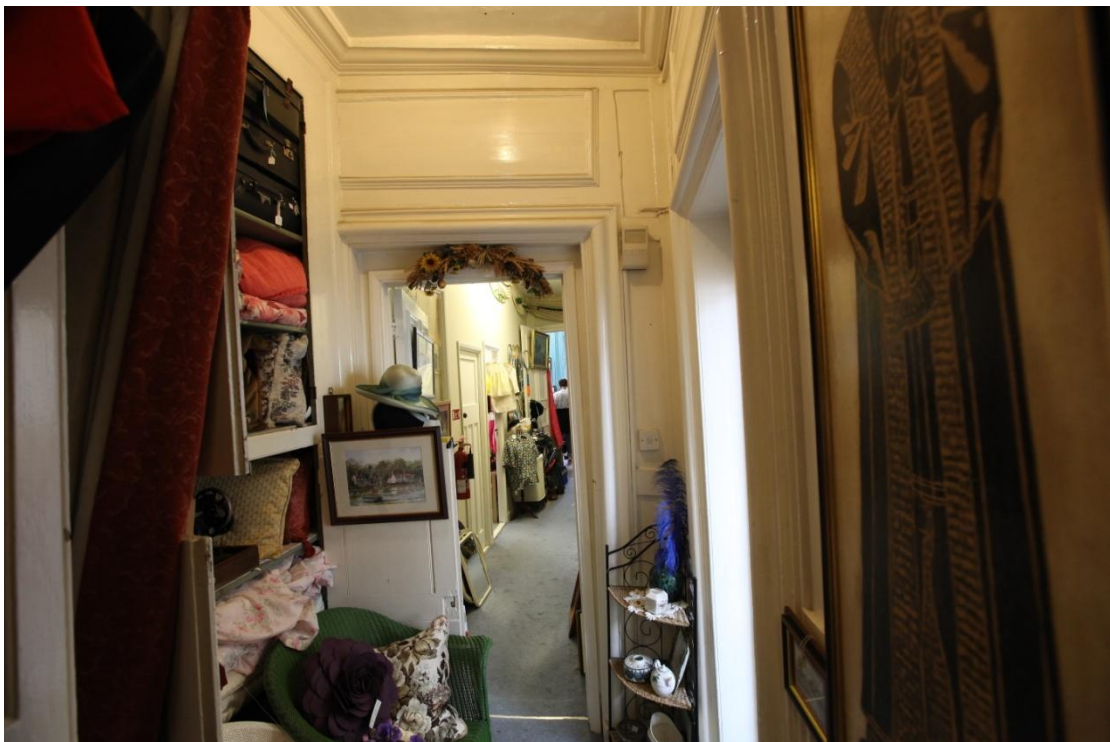
Illus. 15. The first-floor lobby at the head of the back staircase (Q), seen from the rear (east). The fine bolection-moulded door surrounds, panelling and cornice are all consistent with *circa* 1700, but the partition on the far left, which forms the present corridor, is a 20th century insertion.

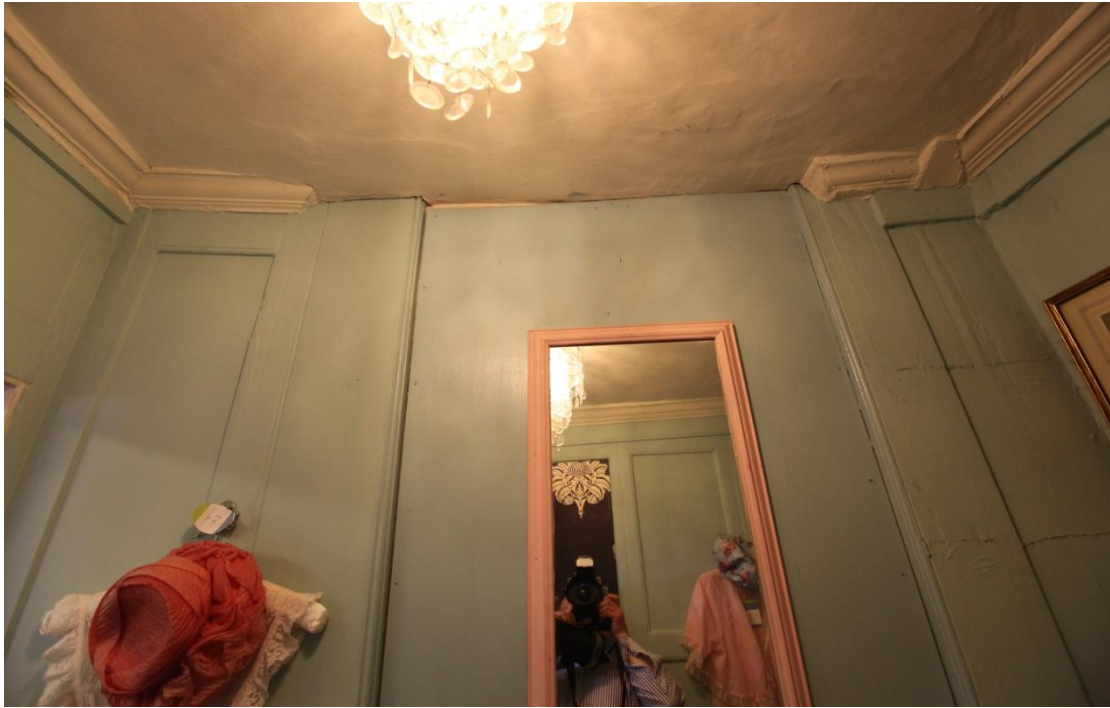
Illus. 16. The southern wall of the narrow first-floor cupboard adjoining the chimney between the two principal first-floor rooms in the charity shop (W). The original moulded cornice of *circa* 1700 turns outwards, indicating that a missing oriel window projected into Sir Isaac's Walk.

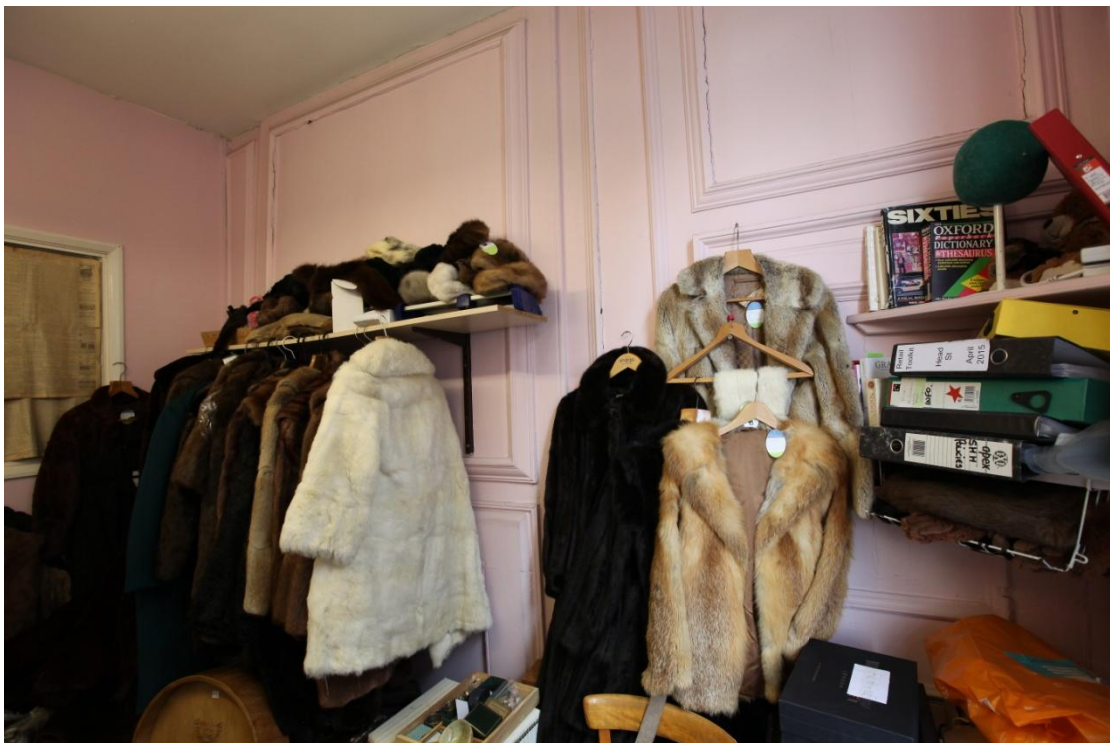
Illus. 17. The fine bolection-moulded panelling and first-floor fireplace to the west of the central chimney in the charity shop (now in the manager's office, V). The door on the right opens into the cupboard shown in illus. 16 above (W). This is the only original chimney not to have lost its external stack, although it now contains a WC on the ground floor. Panelling of this period was invariably painted and early pigment may survive beneath the modern surface.

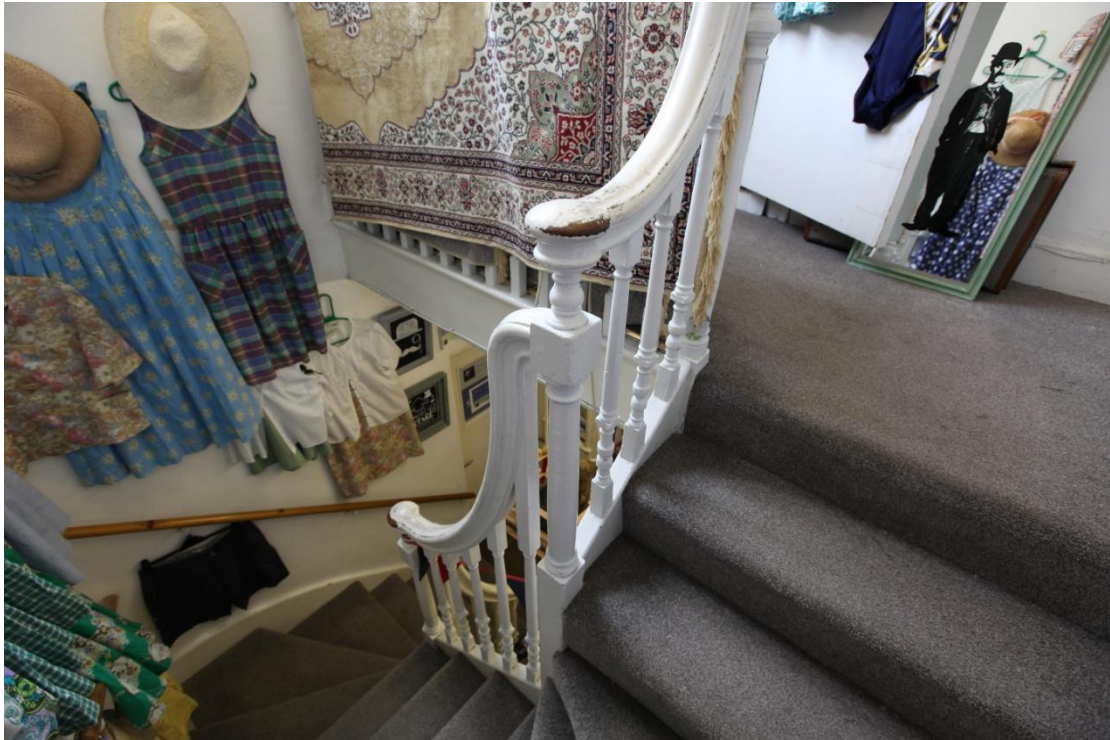
Illus. 18. The back stair in the charity shop (I/Q), with identical balusters and mouldings to the main staircase but lacking its open strings. The attic rooms are reached by a separate stair from the landing on the right. The presence of two 18th century stairs of this quality illustrates the exceptional status of the house.

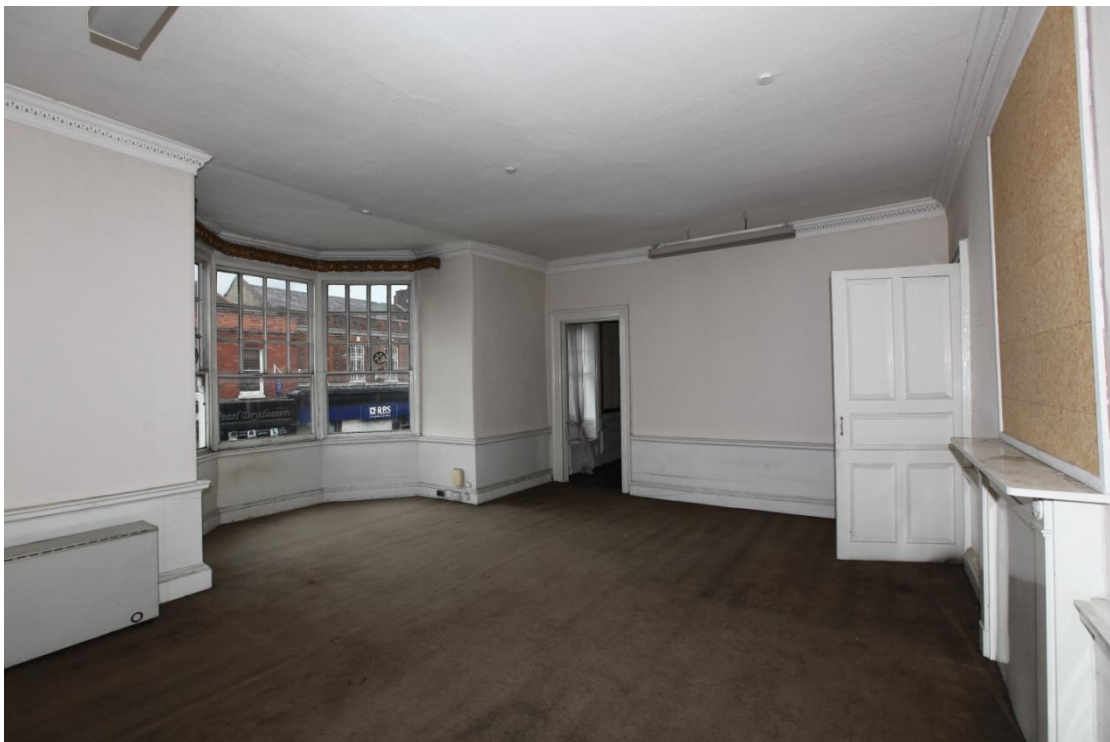
Illus. 19. The spacious first-floor reception room at the head of the main staircase, with the early-19th century oriel window to the left. This room was entirely refurbished when the window was added, with a contemporary fire surround on the right, plain wainscot and a Greek Key cornice (now much filled with paint).

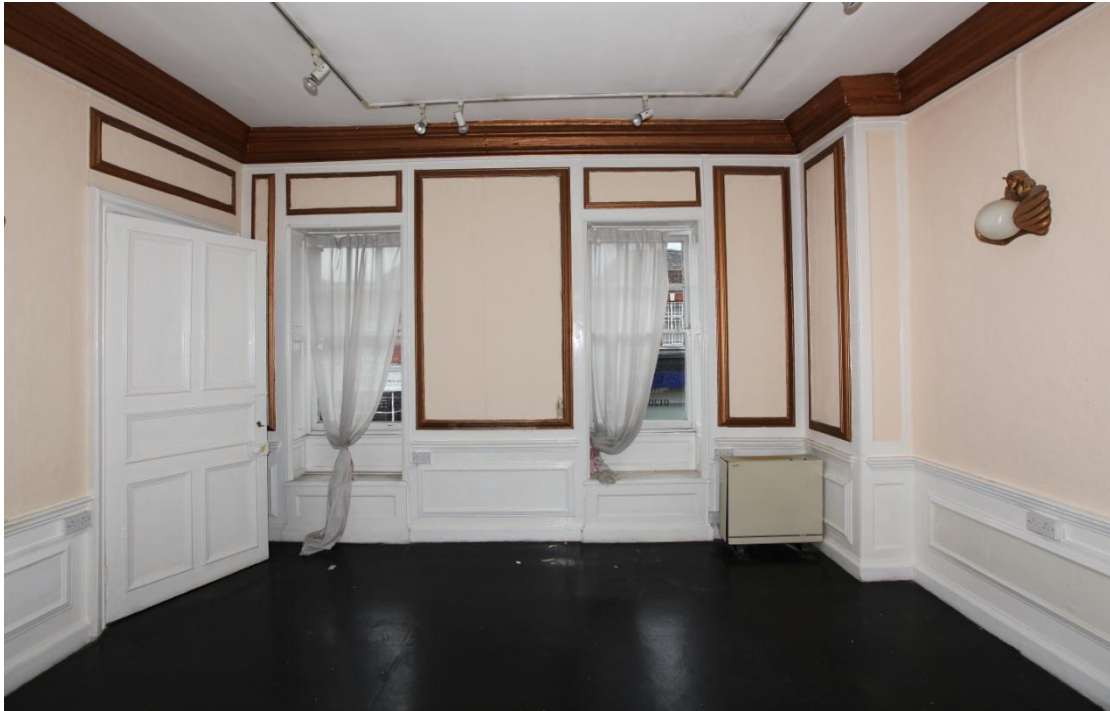
Illus. 20. The Head Street facade of the front first-floor room, above the party shop to the north of the reception room (O), showing its intact cornice and panelling of *circa* 1700. The small horizontal panels above the present windows are later insertions, and the original windows would have risen to the ceiling.

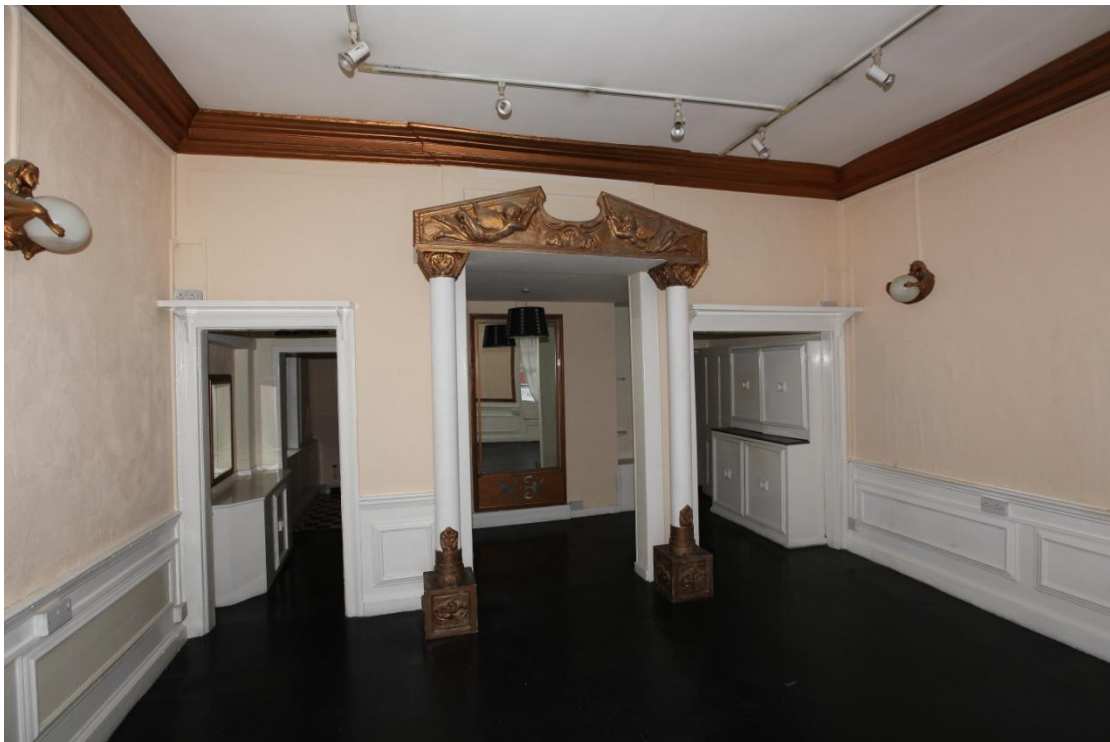
Illus. 21. The rear wall of the front room above the party shop (O). The narrow bay between the two door surrounds was designed for a chimney with back-to-back fireplaces, but sadly this was entirely removed after 1951 (figure 16 shows five chimney pots, of which one - perhaps a later addition – probably served the attic room). The cornice steps forward to respect the missing fireplace, but the broken pediment and columns are modern set dressing for a hair salon that formerly occupied the premises.

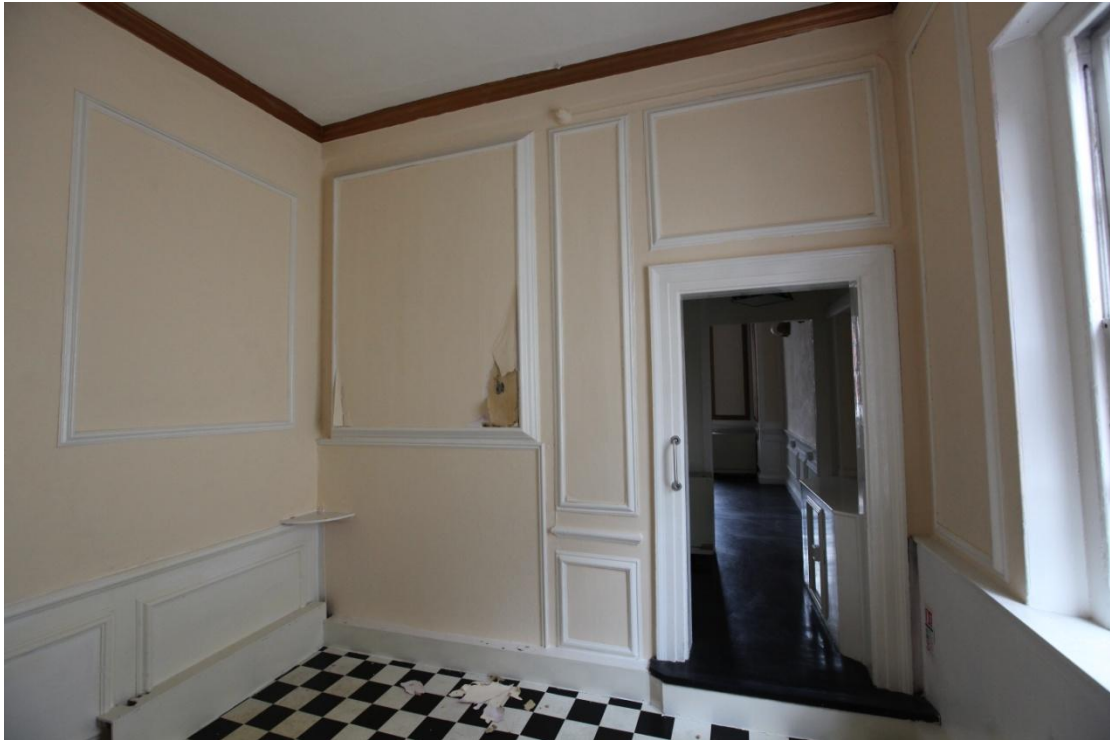
Illus. 22. The central first-floor room above the party shop (L), looking west towards the missing chimney with the outline of a second fireplace to the left. The panelling to the right appears to survive from *circa* 1700 but the wall on the left is a later insertion with sections of applied panelling that interrupts the fire surround. This space formed a single large room initially (i.e. K, L & M).

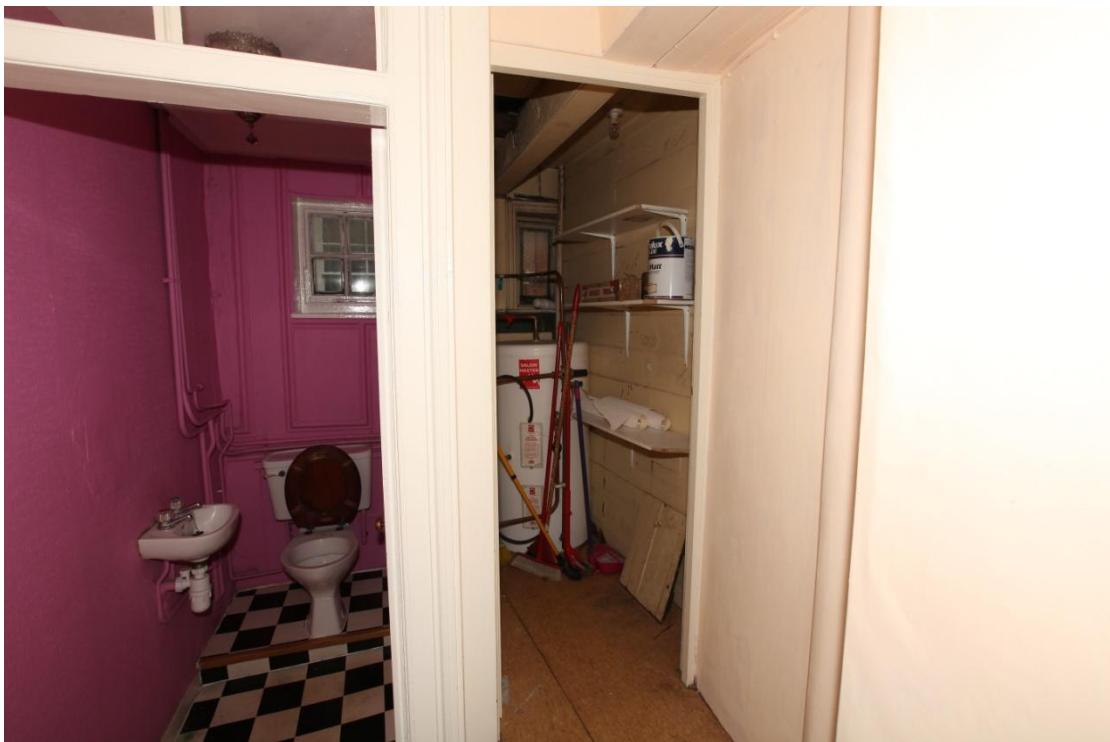
Illus. 23. The WC and boiler cupboard to the rear (east) of the central room above the party shop (K), showing the original panelling of the northern wall which continues from the room in illus. 22. The cupboard appears to be a 19th century insertion, but the WC is modern.

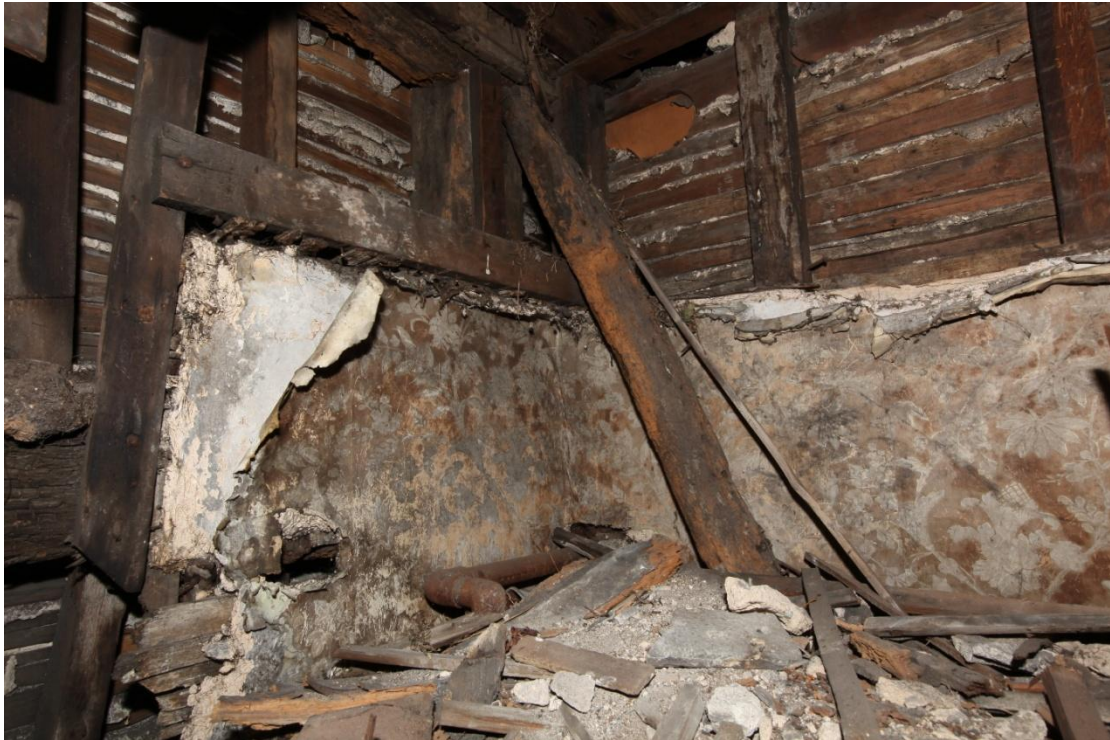
Illus. 24. A detail of the north-eastern corner of the boiler cupboard in illus. 23, showing an area of well preserved printed wall paper that may survive from *circa* 1700 and is certainly no later than the mid-18th century. Remains of a missing lath-and-plaster ceiling are visible at its upper edge. The few exposed wall timbers in this space contain unpegged mortises and show evidence of re-use, as expected in *circa* 1700. There is no visible medieval fabric at this level of the building.

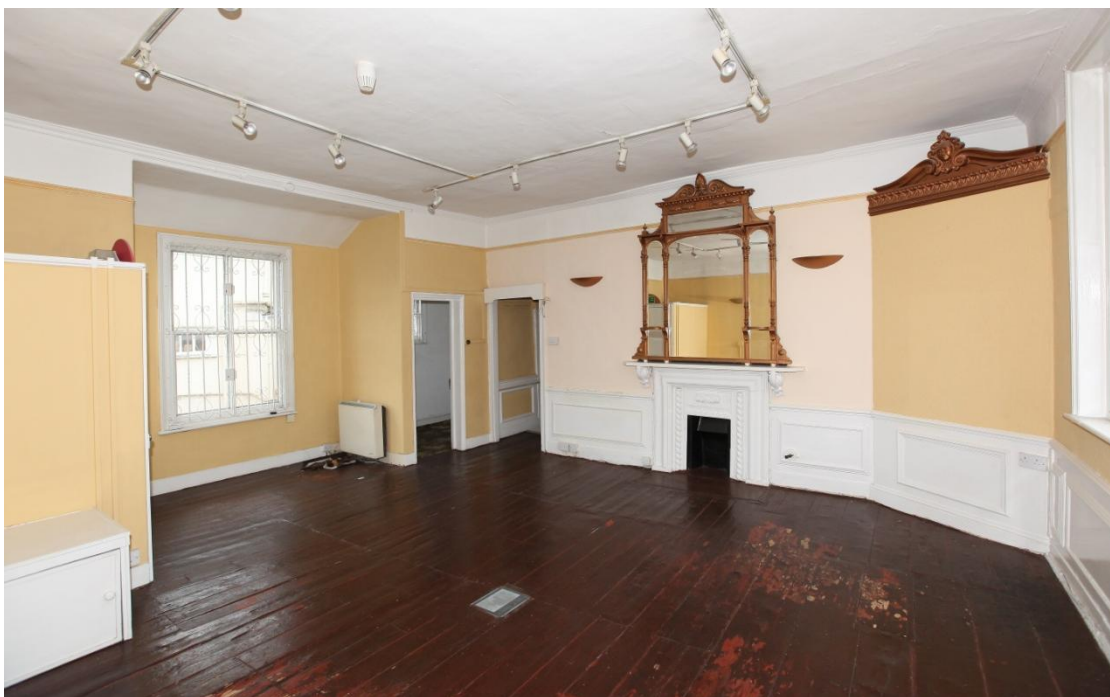
Illus. 25. The spacious rear room above the party shop (J), seen from the east, with wainscot and a fire surround of *circa* 1700. An ostensibly original door is hidden behind the modern corner piece on the right, which would have opened into the cupboard in illus. 23. The lean-to bay window to the left is a 19th century slate-roofed addition.

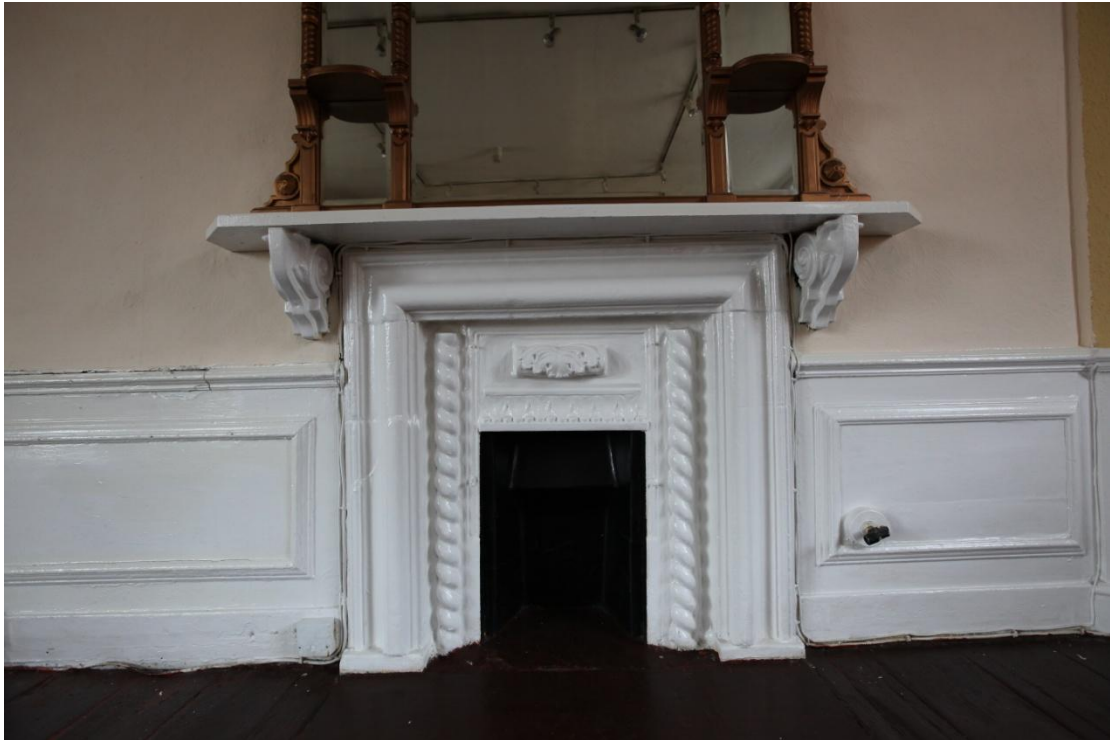
Illus. 26. A detail of the fine bolection-moulded stone fireplace and wainscot in the rear first-floor room of the northern wing (illus. 25). The coal grate and barley-twist columns are 19th century insertions but are themselves of historic interest. The shelf is a relatively recent addition on re-used brackets.

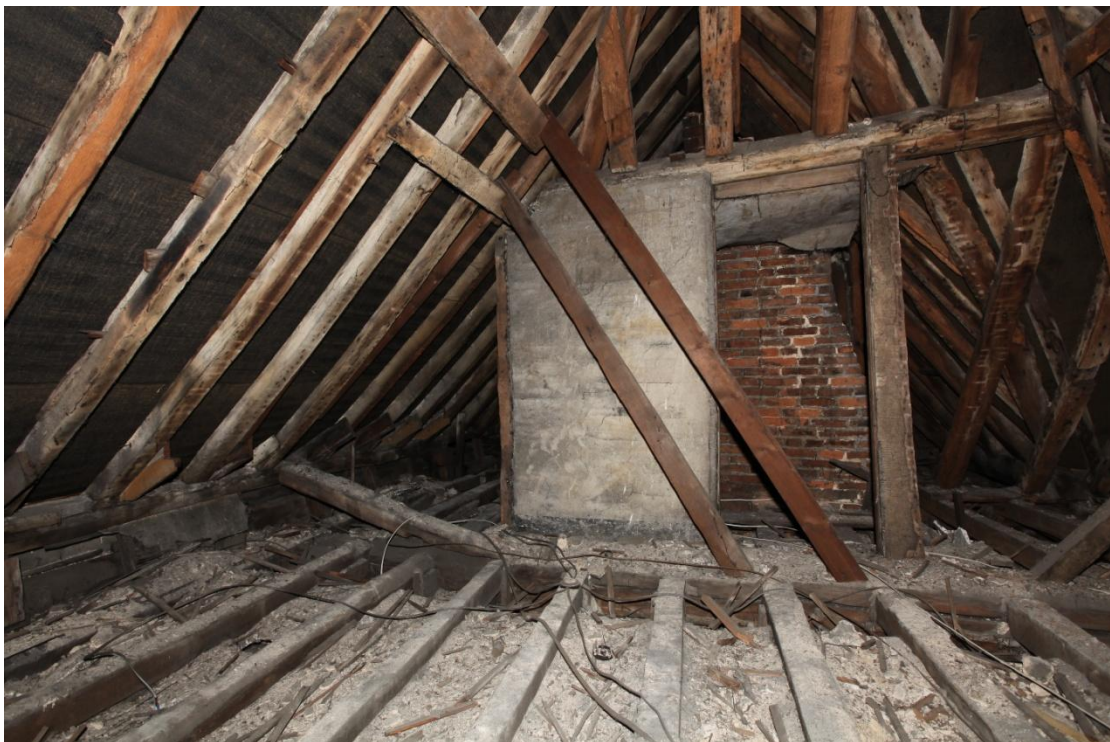
Illus. 27. The roof structure above the rear room of the northern wing (J) showing a plastered cupboard adjoining the truncated chimney. The main roof in this part of the building was rebuilt in the 19th century but the direction of the rafters above the cupboard indicates that it was formerly at right-angles to its present axis and would have terminated in a north-facing gable.

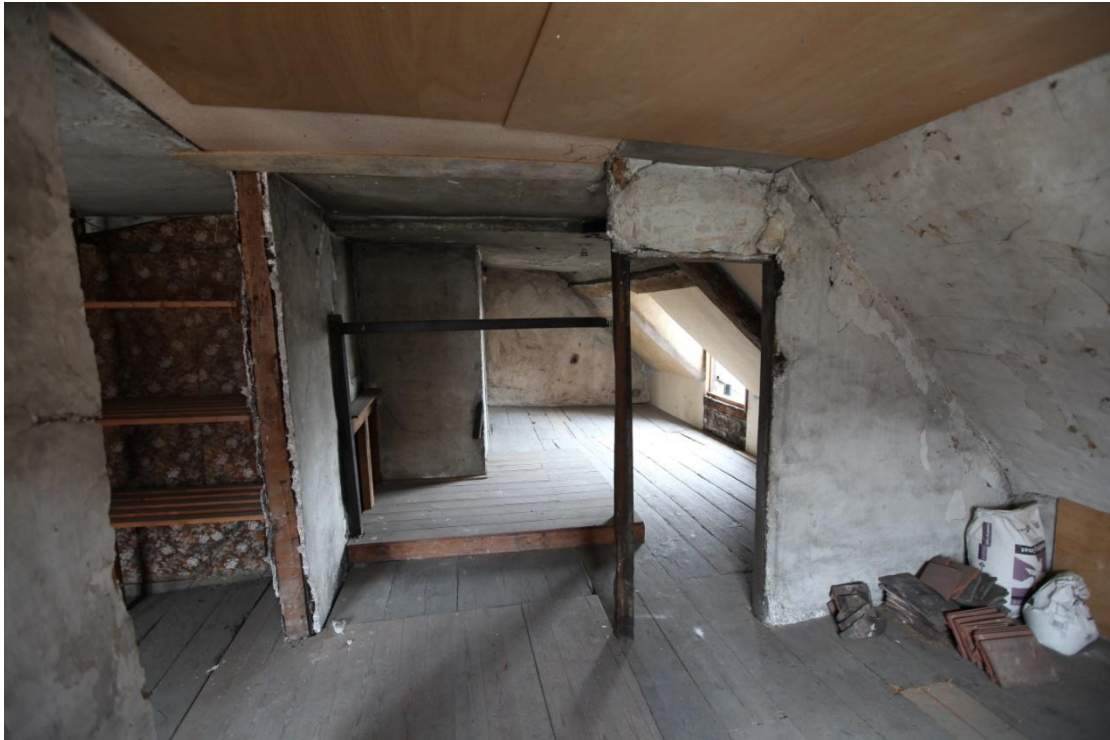
Illus. 28. The lath-and-plaster partitions in the attic of the Head Street range, seen from the north. The broken wall to the left and the patched ceiling relate to the missing chimney shown to the left in figure 17. The access to the lead roof detailed in illus. 29 below is visible in the rear to the right.

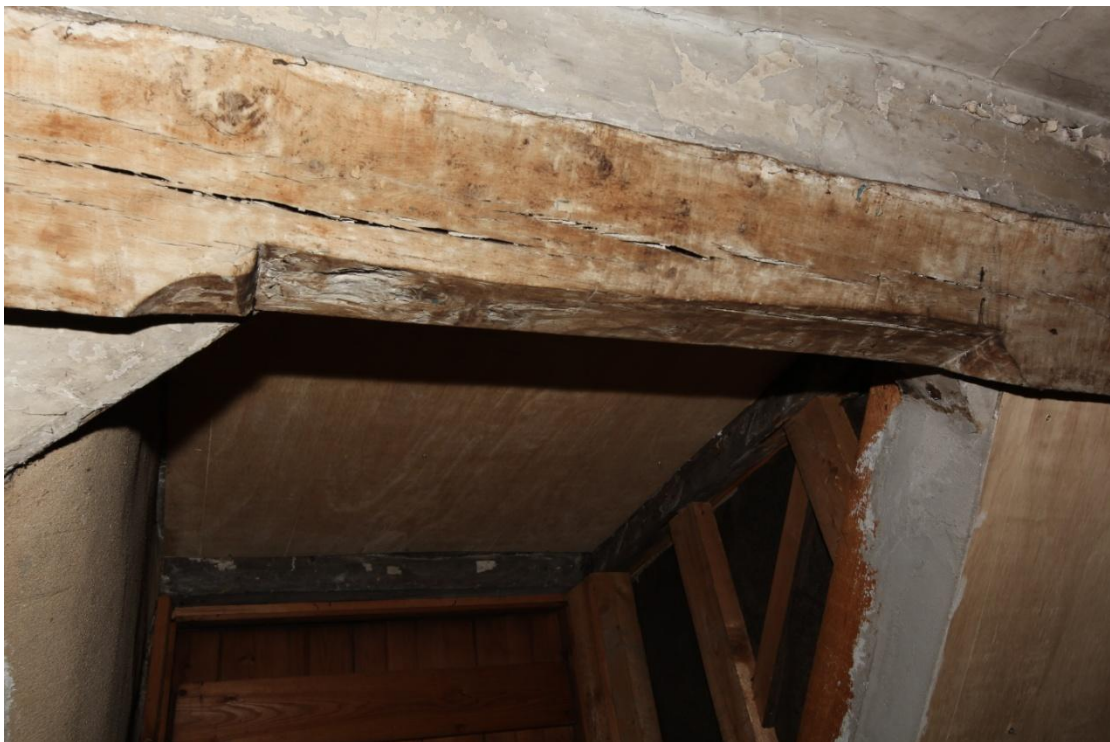
Illus. 29. A detail of the roof purlin adjoining the present access door to the lead roof adjoining Head Street, with an original chamfer which suggests this area was occupied by a similar dormer window or access from the outset. This is only such chamfer in the front elevation, although some of the equivalent purlins are either hidden or renewed.

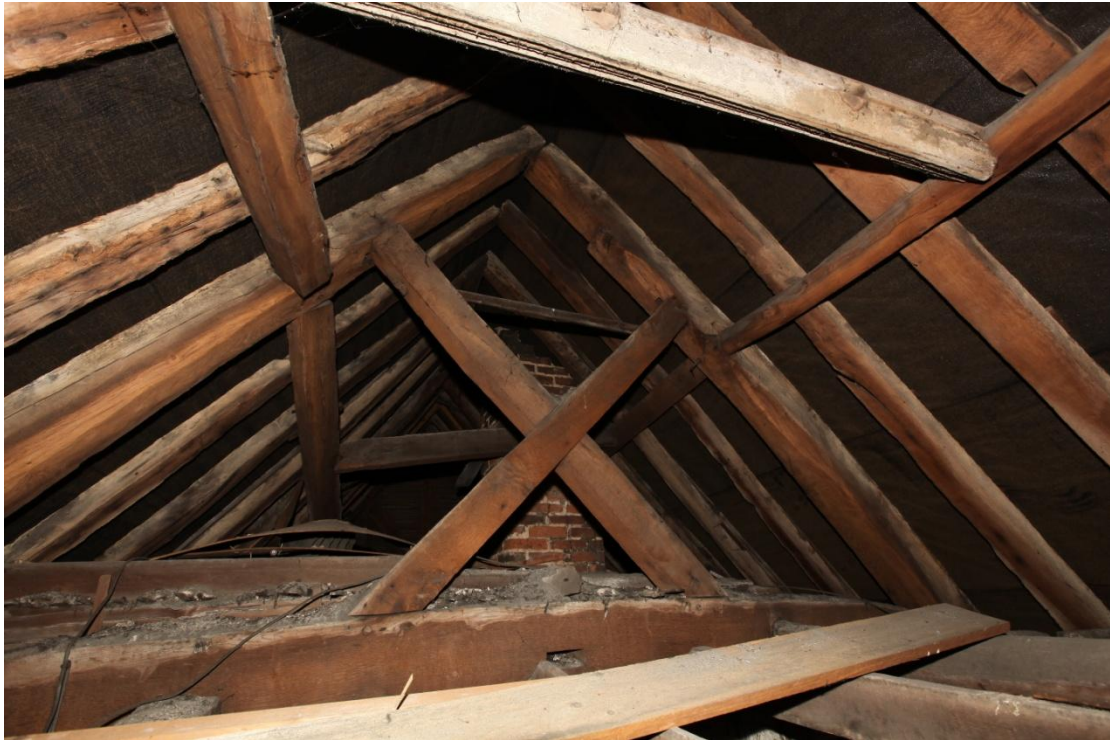
Illus. 30. The roof structure of the Head Street range, looking south towards the chimney of the main first-floor reception room which has been truncated below the ridge. The collar is Saltire-braced to the principal rafters, with two tiers of linear butt-purlins and copious re-used timber. The collar at the top of this image is a re-used early-17th century window lintel with impressions of ovolo-moulded mullions, but may be a later insertion.

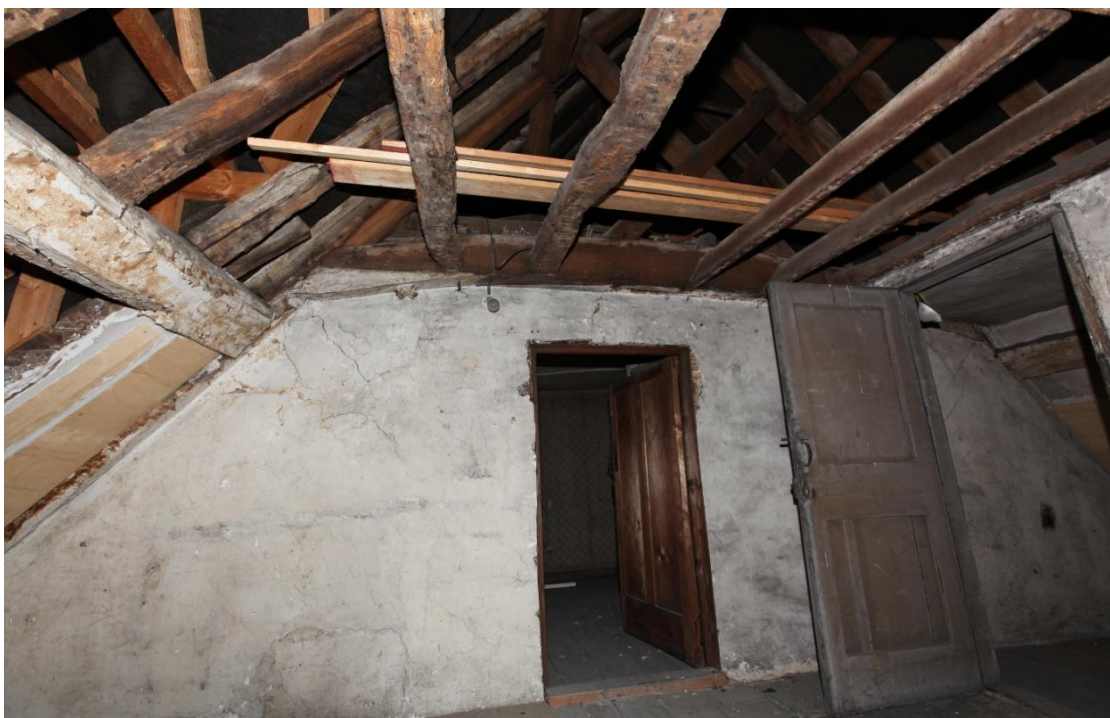
Illus. 31. The entire roof truss shown in illus. 30 above, with the lower butt-purlin to the left and the joists of a missing plaster ceiling. Most of the plasterwork in the attic appears to date only from the early 19th century, but the collar contains a pegged central mortise that may have secured the axial joist of an original ceiling.

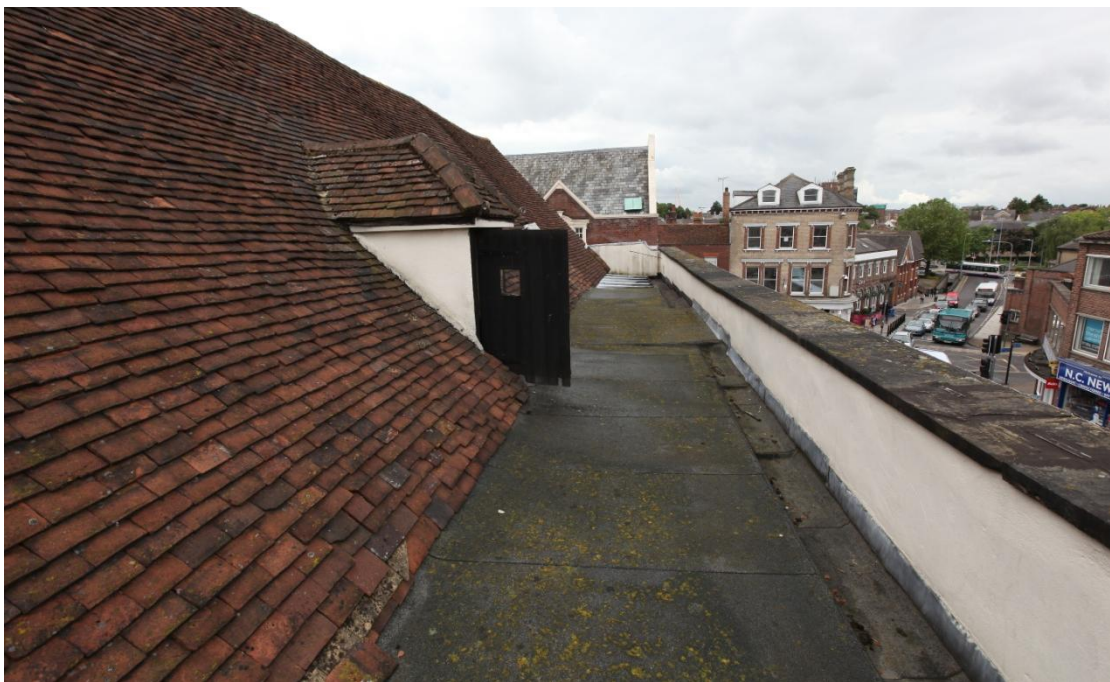
Illus. 33. The wide area of flat roof between the Head Street parapet and the tiled roof, showing the present access hatch on the left. An area of leadwork can be seen in the rear but the majority appears to be covered only in felt (possibly concealing lead). This unusual arrangement corresponds with the building’s depiction in 1745 with a low attic storey beneath a shallow roof; this was presumably achieved by adding a false vertical wall to the front of the rafters to create – in effect - a continuous dormer.

The most unusual feature of the facade is the extent to which it projects by approximately 6 feet beyond the main roof to create the ‘leads’ shown in illus. 33. There is nothing to indicate this is the result of a later extension and the arrangement reflects the shallow attic storey with its large central dormer of 1745. Such a facade would have been highly abnormal in its day, and was presumably created by linking a series of lean-to dormer windows which rose vertically from the leads. The butt-purlin above the present access hatch is neatly chamfered and stopped in the late-17th century style to suggest it was always intended as a doorway and it may not be fanciful to imagine Sir Isaac Rebow and even William III exhibiting themselves to the townsfolk from this vantage point.
