The Temple of Claudius at Colchester Reconsidered*

By P. J. DRURY

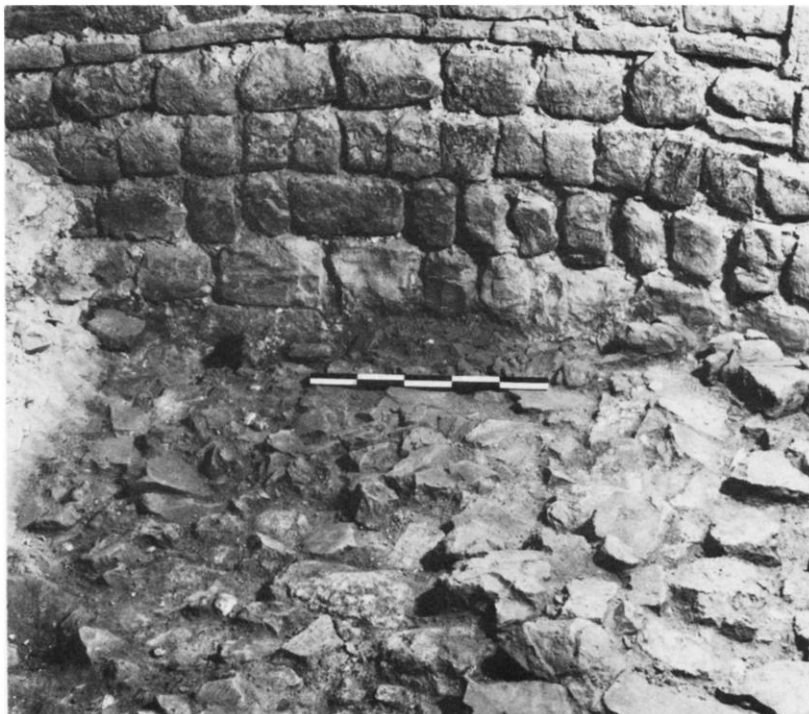
A. Colchester Castle Keep: View looking north, of part of the weathered and irregular surface of the tile and concrete raft, 15, exposed in the sub-crypt, 1977. Compare with the detailed plan, FIG. 5 (p. 9).

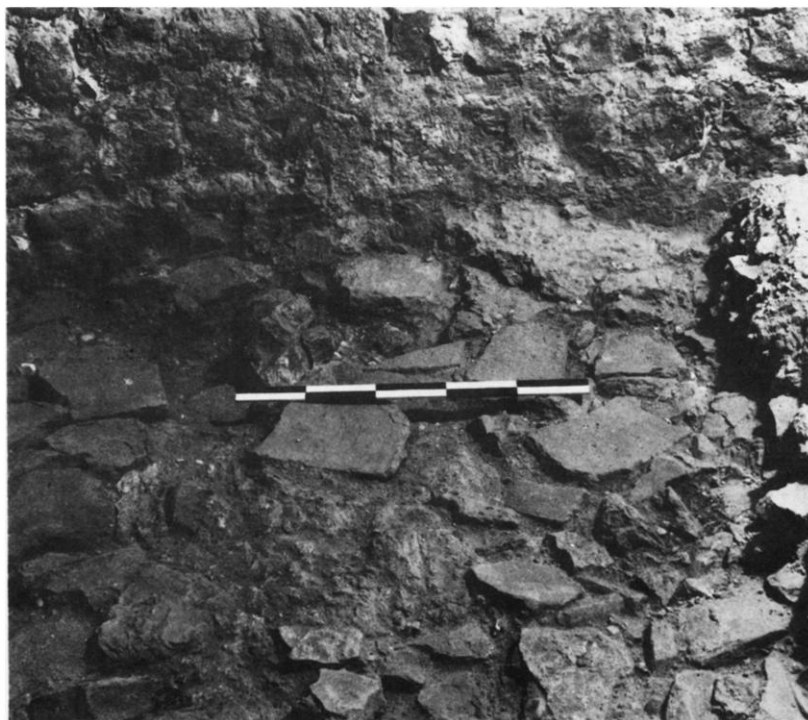
B. Colchester Castle Keep: The tile and concrete raft, 15, at the eastern extremity of the apse of the sub-crypt, showing how the mortar of the Norman wall seals the raft. The line of Section 2 is on the right of the picture. Compare with FIG. 5 (p. 9).

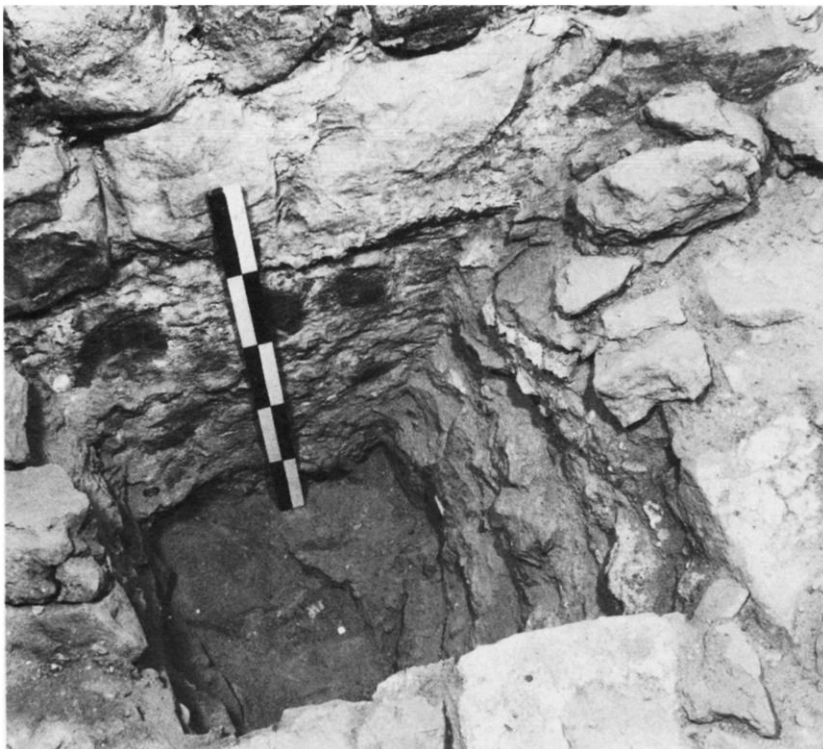
A. Colchester Castle Keep: Sondage cut through the tile and concrete raft against the north wall of the sub-crypt; Section II, with which the photograph should be compared, is on the right of the picture (p. 10).

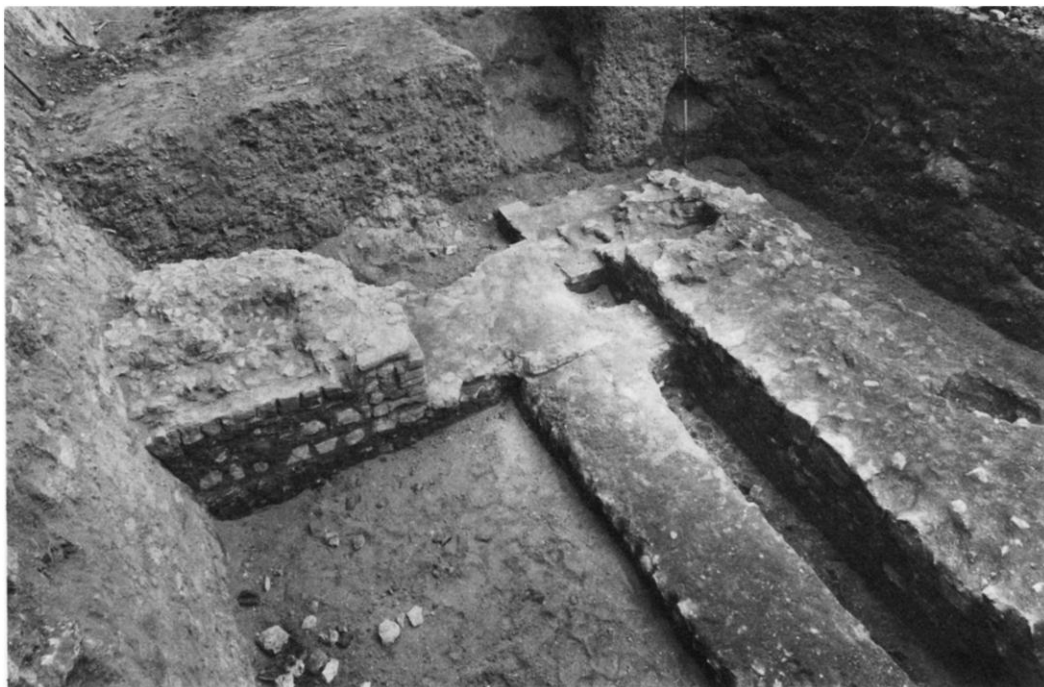
B. Colchester Castle: The Roman base, 143, partly covered by the wall of the Norman (Period VIII B) forebuilding (p. 15).
